**Central Queensland Coal Project
Appendix 10g – 2018 Waterway
Barrier Works Map Amendment
Request**

Review of waterway barrier works mapping intersecting the Central Queensland Coal Project (ML80187)

Attachment A – Styx Coal Project waterways on south side of Bruce Highway

Attachment B – Styx Coal Project waterways on north side of Bruce Highway

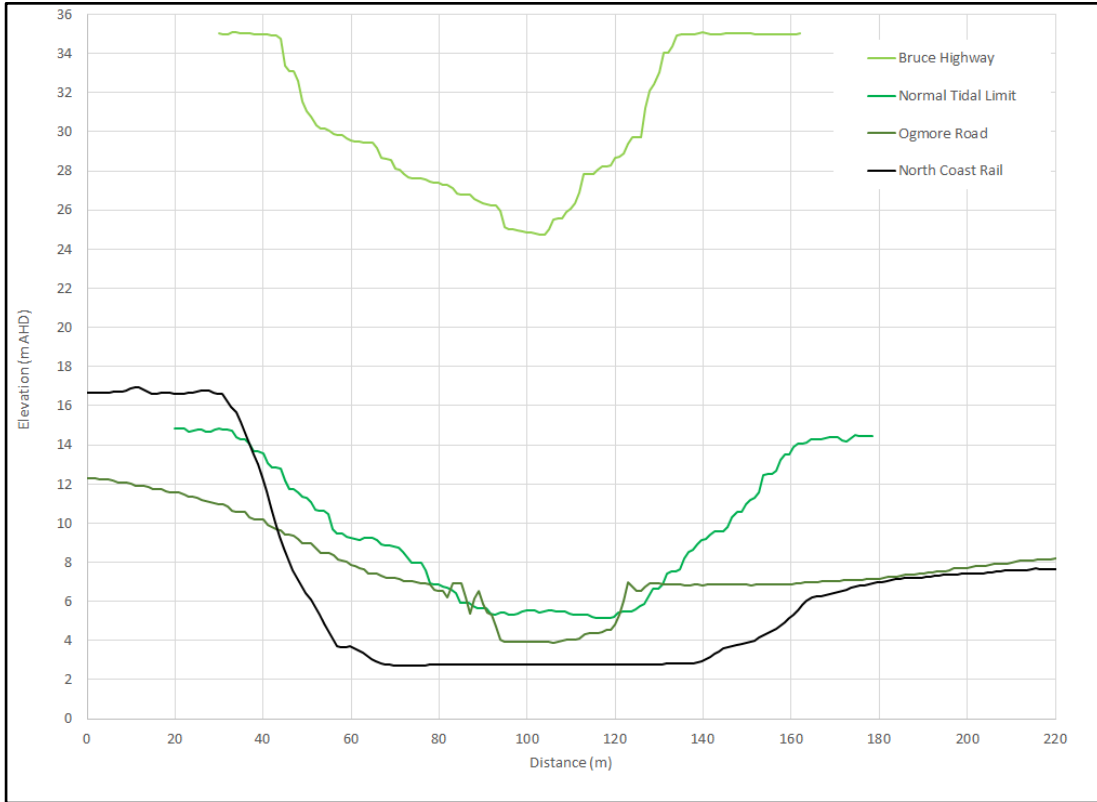
Figure 2 Comparative cross-section of watercourse crossings in area from LIDAR (Deep Creek shown at top)

The mapped drainage features sit on the Deep Creek floodplain and outside the effective flow area. The catchment area of the subject waterways is small and topography relatively flat. Deep Creek itself is a steeply incised channel and highly ephemeral. Figure 2 below shows the channel of Deep Creek is approximately 10 m below the adjacent bank height where the Bruce Highway crosses the creek (based on recent LIDAR survey).

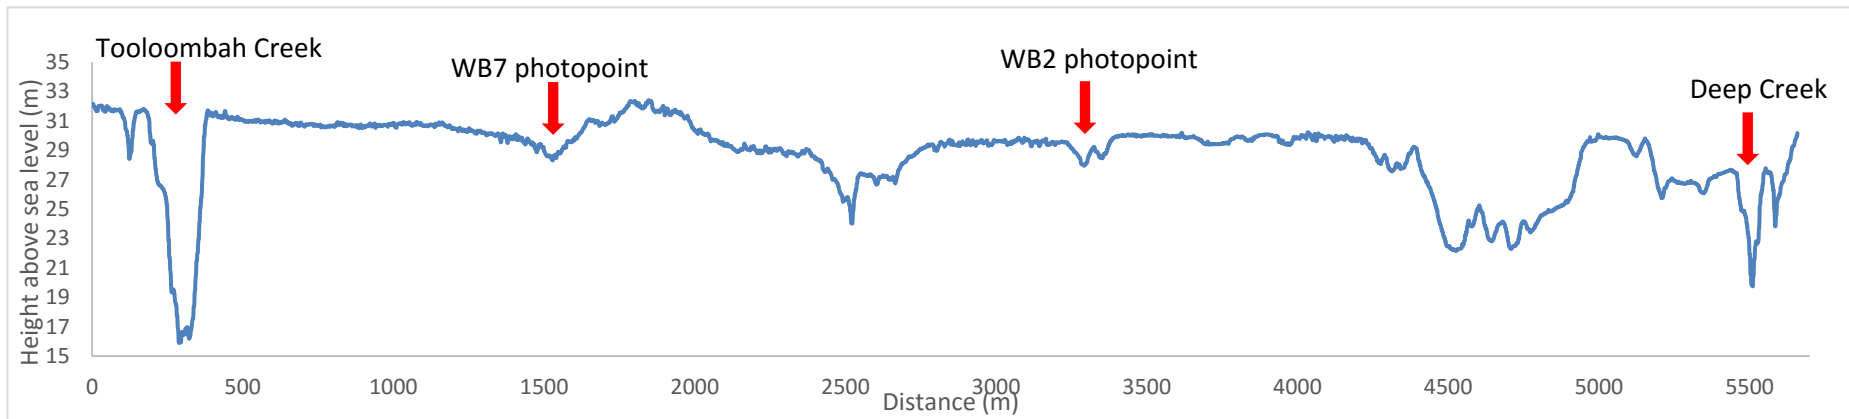
Figure 3 Elevational cross-section of waterway barrier risk features to north of the Bruce Highway

Figures 3 and 4 provide a comparative elevational cross-section of the drainage features crossing the subject property. The cross-sections are depicted from above in Figure 1 for visual reference to the landscape. The cross-section to the north of the highway (Figure 3) crosses (approximately) through two of the photo points depicted in Attachment 2. The cross section at WB7 demonstrates the depth of the feature is 2.5 m below the surrounding landscape with channel slopes extending 100's of metres from the deepest point. The cross section at WB2 crosses the feature twice where an 'S' bend occurs. The depth of the feature is less than 2 m below the surrounding landscape with gentle channel slopes and an overall width of approximately 70 m.

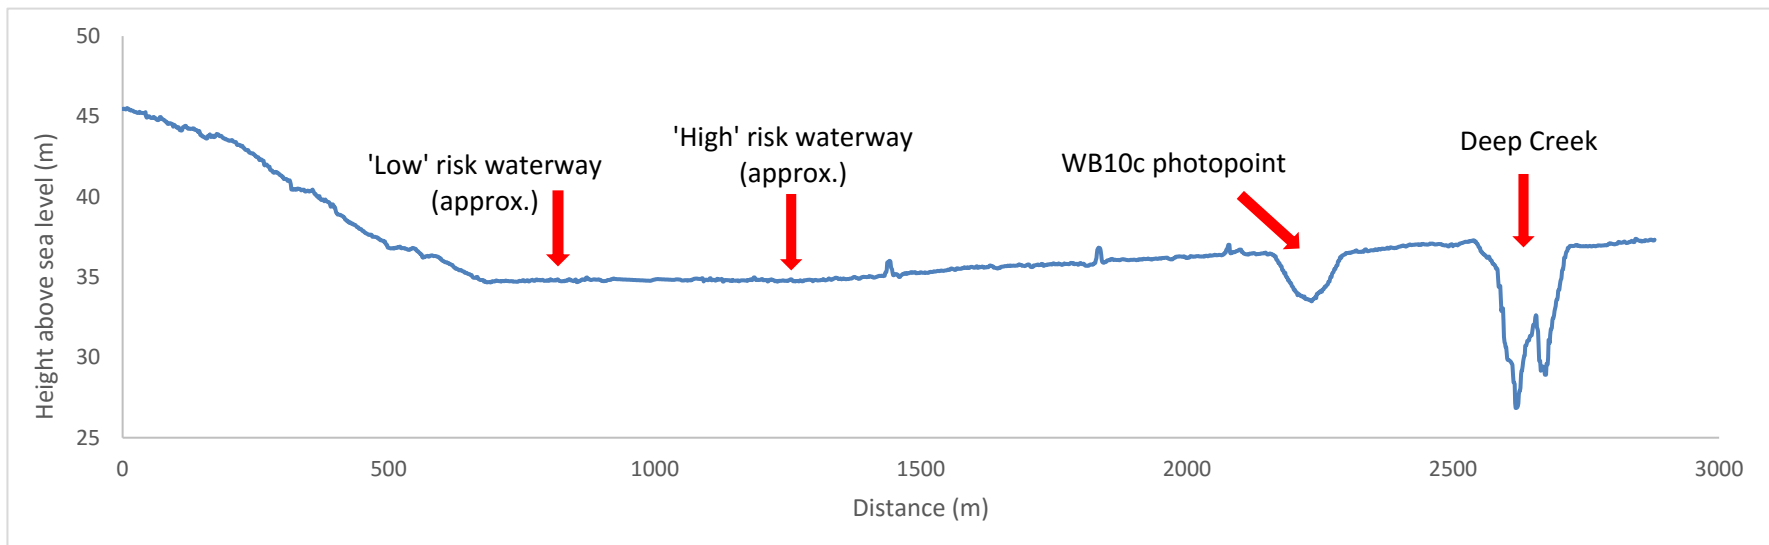
Figure 4 Elevational cross-section of waterway barrier risk features to south of the Bruce Highway

The cross-section to the south of the highway (Figure 4) shows the approximate position of the mapped 'risk' features demonstrating there is no channel at all in these areas. The cross section at WB10c (refer Attachment 1) demonstrates the depth of the feature is 3 m below the surrounding landscape with gentle channel slopes extending across an overall width of over 100 m. There is no evidence of a bank on this feature.

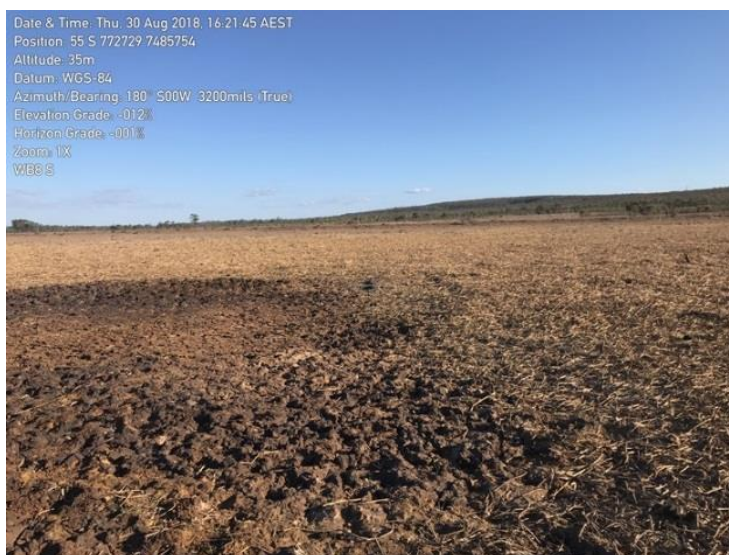
Photos taken 30 August 2018. Photos taken at WB8A point (top of berm).

Photo looking south from WB8a across bermed area

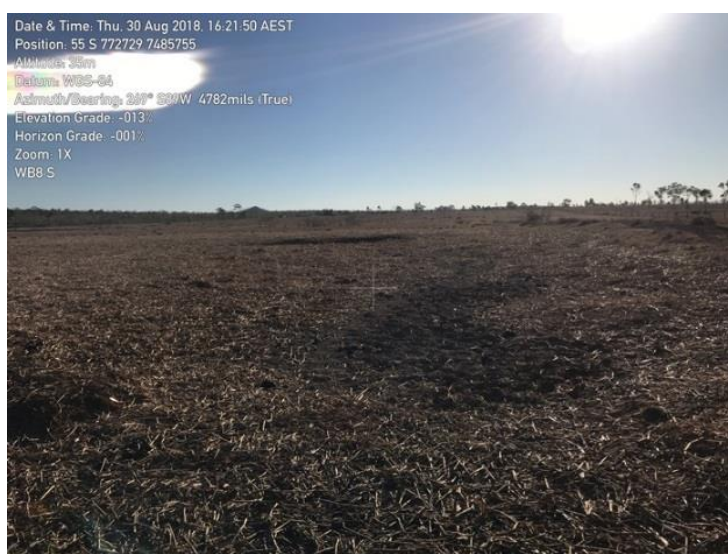
Photo looking west from WB8a across low slope of berm

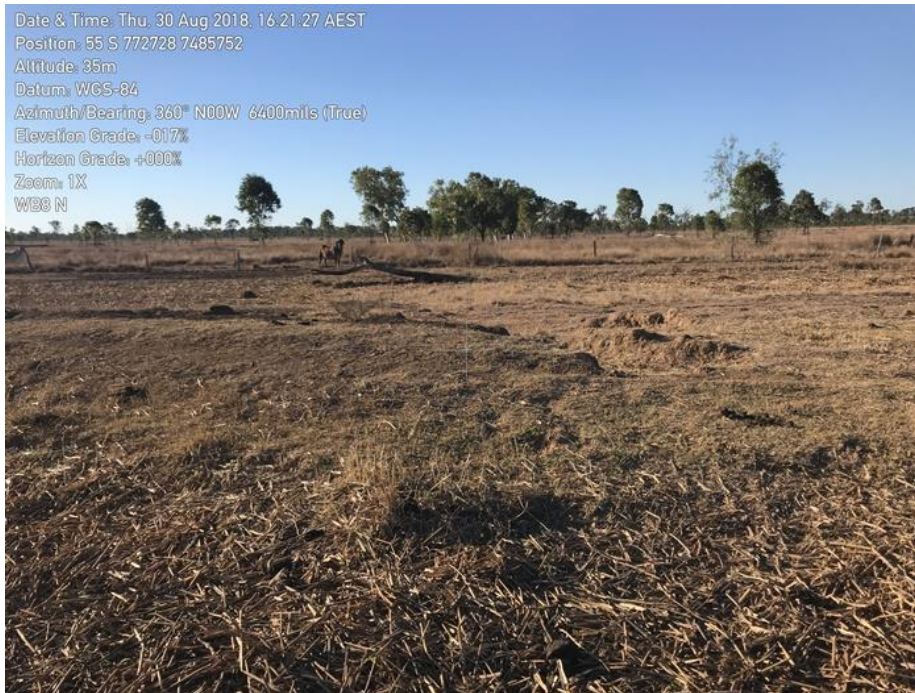
Photo looking north from WB8a showing some erosion but no channel

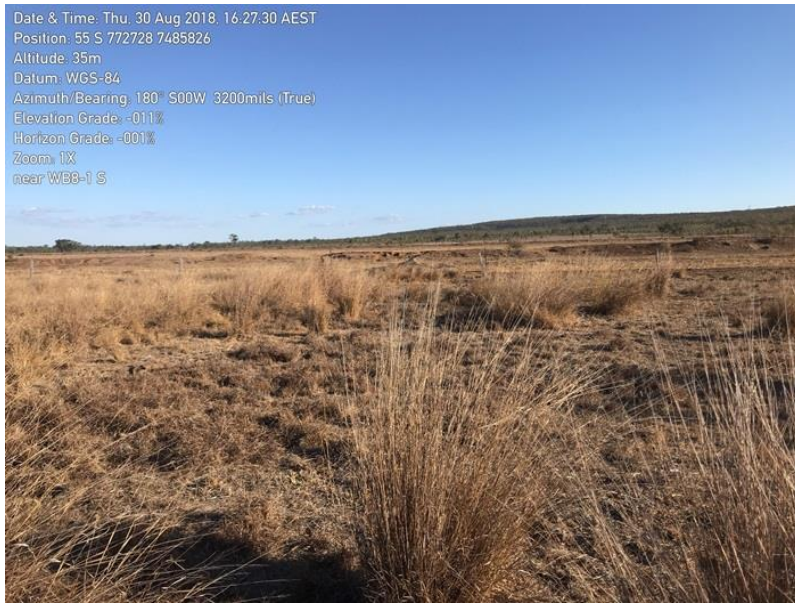
Photos taken at WB8b point (north of berm) – no channel indicated in either view

Photo looking south from WB8b towards bermed area and WB8a

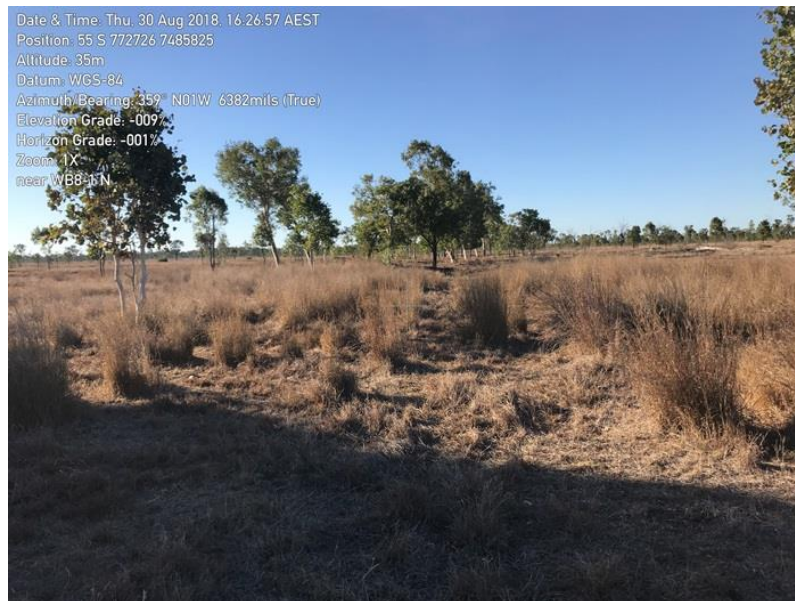
Photo looking north from WB8b

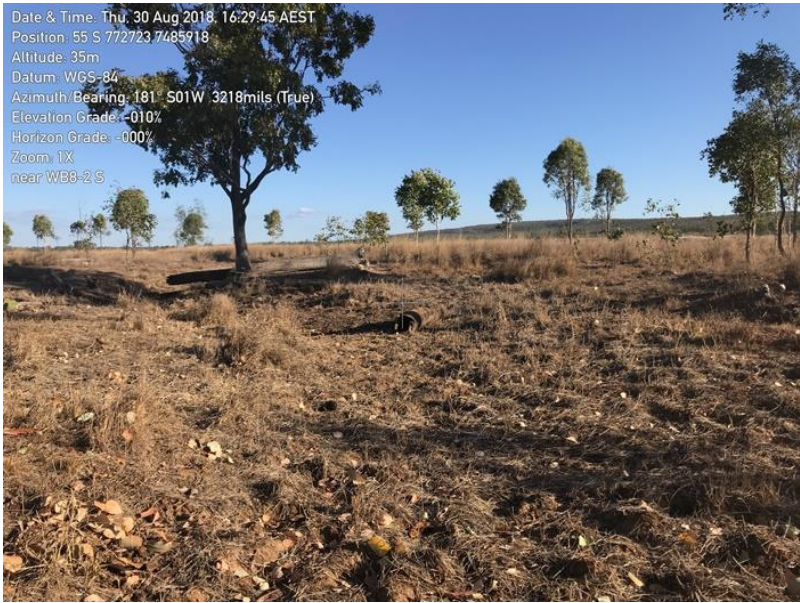
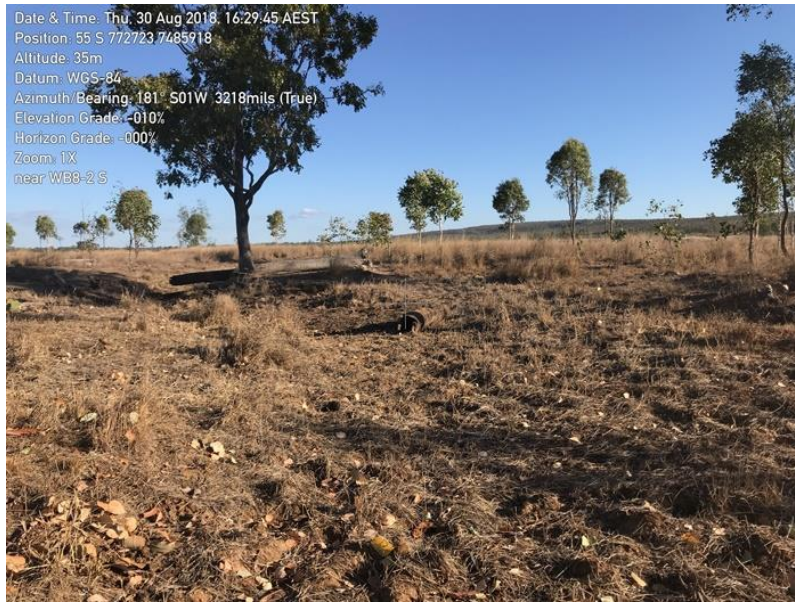
Photos taken at WB8c point – depression observed but no discernible channel indicated in either view

Photo looking south from WB8c towards WB8b

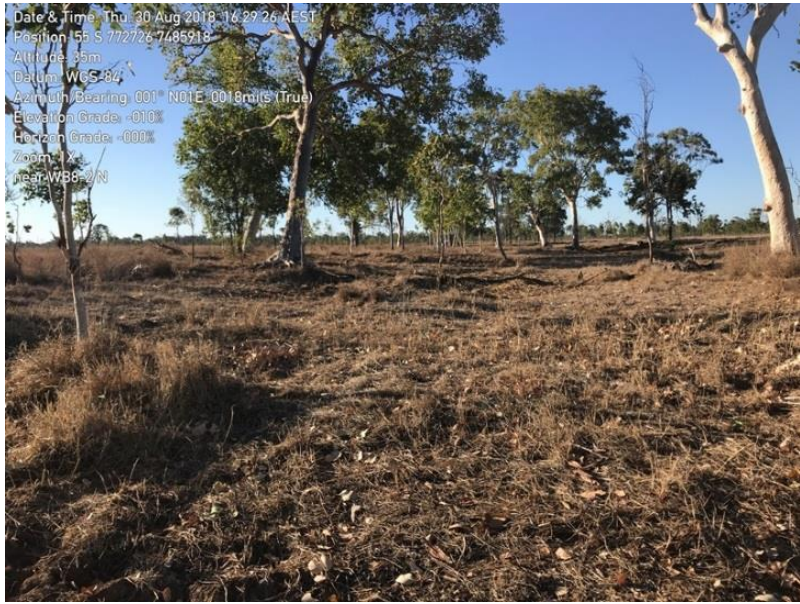
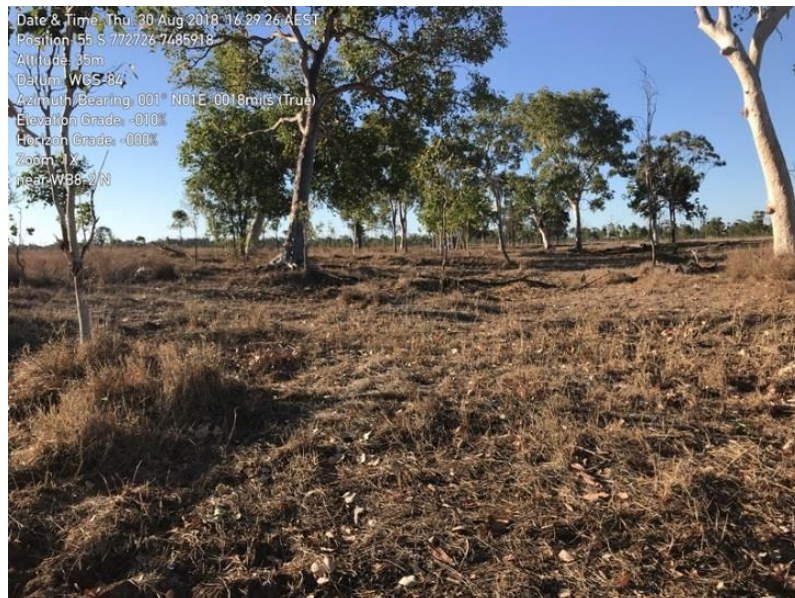
Photo looking north from WB8c towards downstream dammed area and WB8d

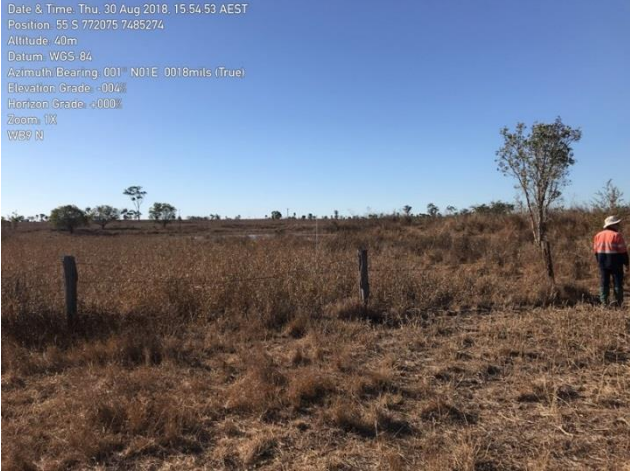
The following photos depict a point located upstream and south-west of the bermed areas. The point is located near a farm dam adjacent to a mapped 'low risk' waterway (indicated on Figure A1 as survey point WB9). Aerial imagery indicates a low overflow area emanating from the dam at this point. However, there is no 'channel' indicated in the site photos or on aerial imagery.

WB9 - looking north from survey point towards dam

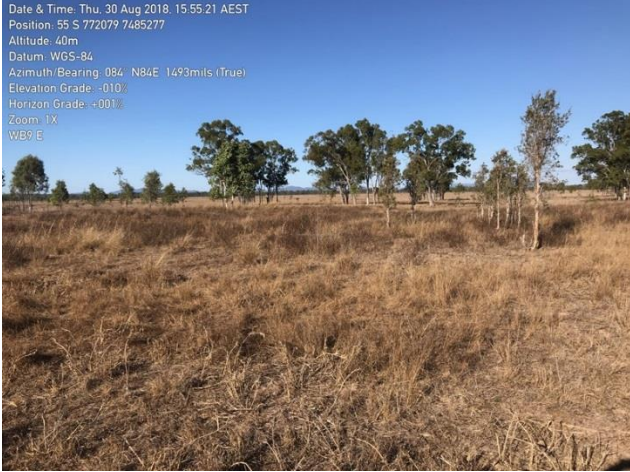
WB9 – looking east from survey point along mapped drainage line

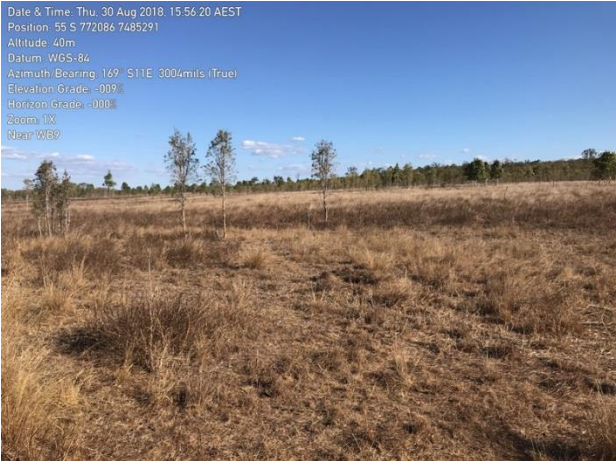
WB9 - looking south from survey point

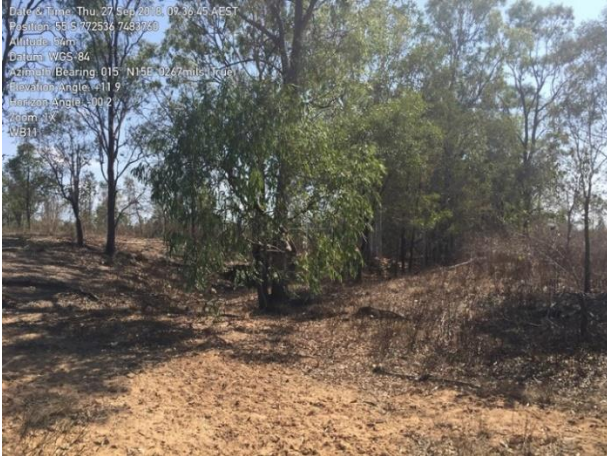
The following photos depict points located along 'low risk' waterways (indicated on Figure A1 as survey points WB11, WB12 and WB13) located upstream of the bermed areas and survey points WB8a-d. These waterways drain a low rocky hill/plateau and are highly ephemeral. The photos indicate very minor channelisation (at best described as a drainage area) and do not represent potential or temporary fish habitat. Photos taken 27 September 2018.

WB11 - looking upstream (south-west) along channel from survey point

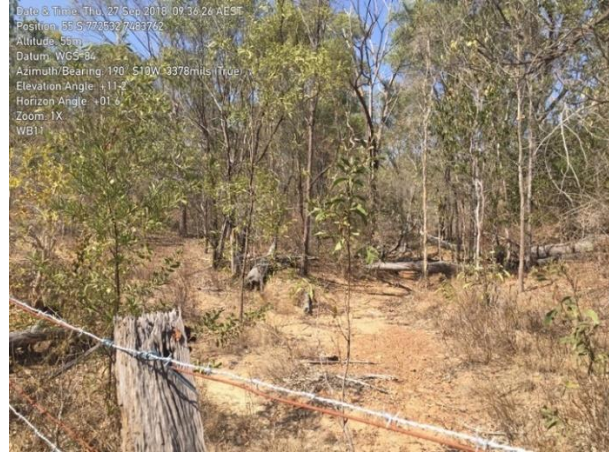
WB11 – looking downstream (north-east) along channel from survey point

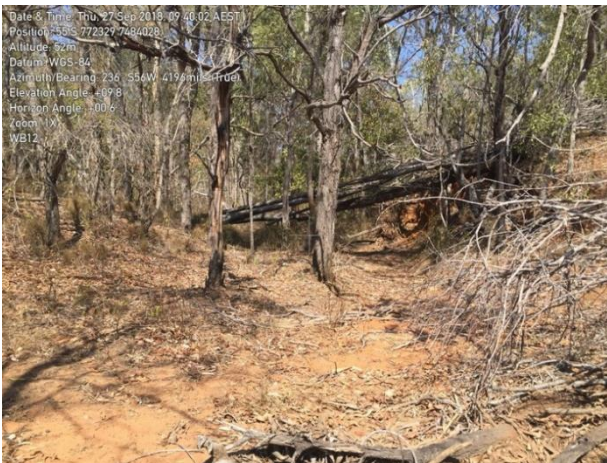
WB12 - looking upstream (south-west) along channel from survey point

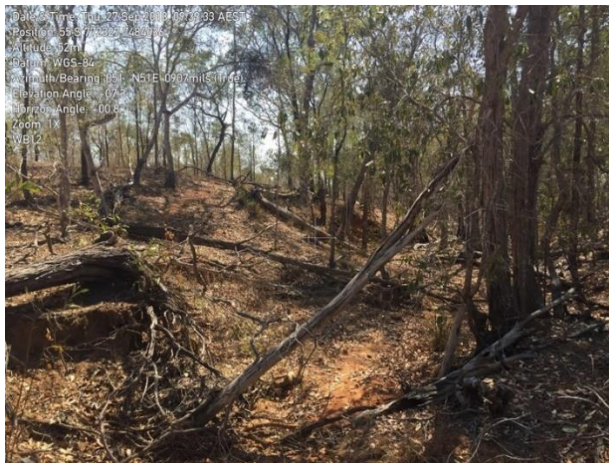
WB12 – looking downstream (north-east) along channel from survey point

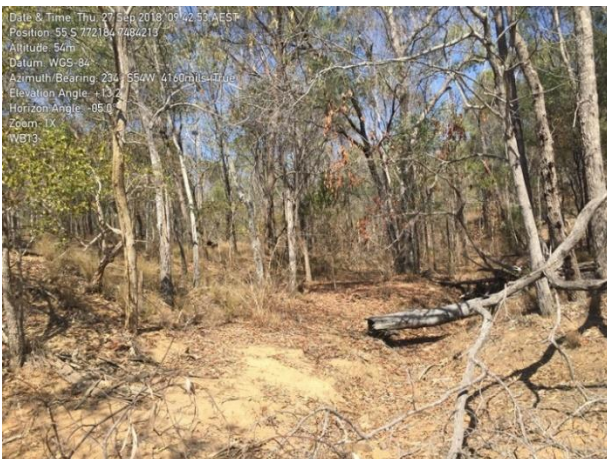
WB13 - looking upstream (south-west) along channel from survey point

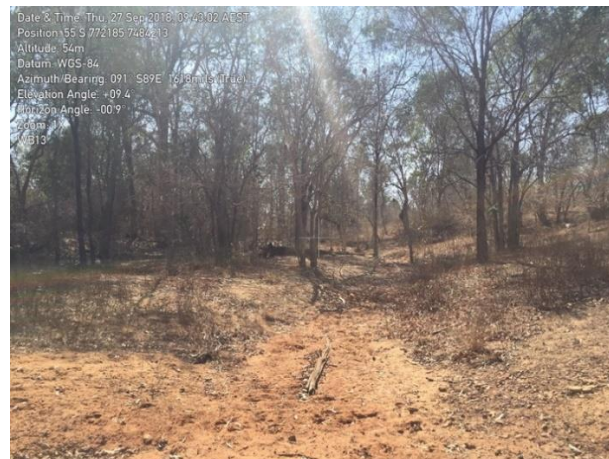
WB13 – looking downstream (north-east) along channel from survey point

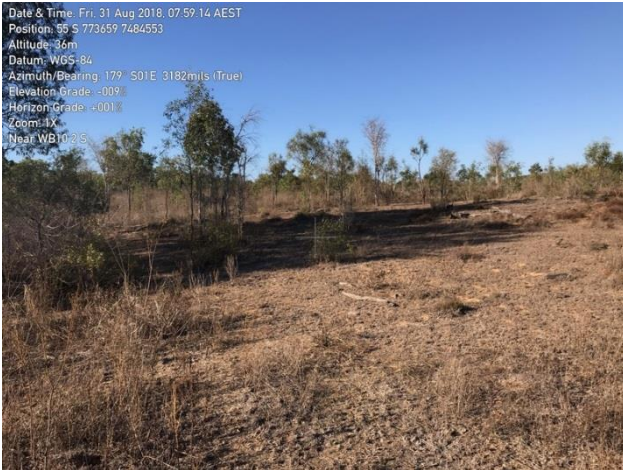
The following depicts a minor channel/gully (described as ‘low risk’ under the mapping) draining a very small catchment which is separate from the catchment described by the previous survey point photos and feeds into Deep Creek (indicated on Figure A1 as survey points labelled WB10a-d). This area comprises a relatively steep eroded gully which does not have any defined bed or banks or provide any potential pooled areas before draining to Deep Creek. There is approximately 260 m between the points depicted - WB10a and WB10d. Photos taken 31 August 2018.

WB10b - looking upstream (south) along gully from survey point

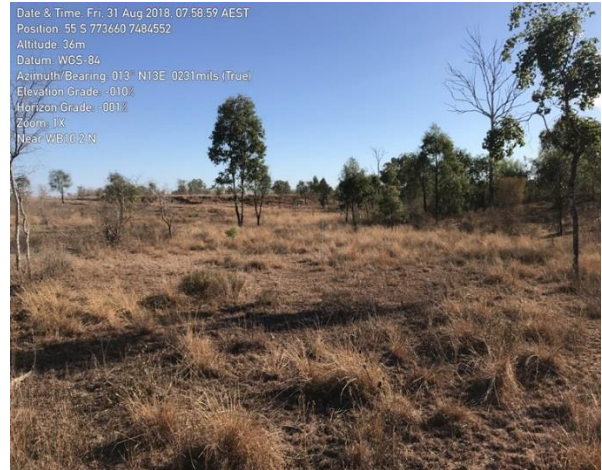
WB10b – looking downstream (north) along gully from survey point

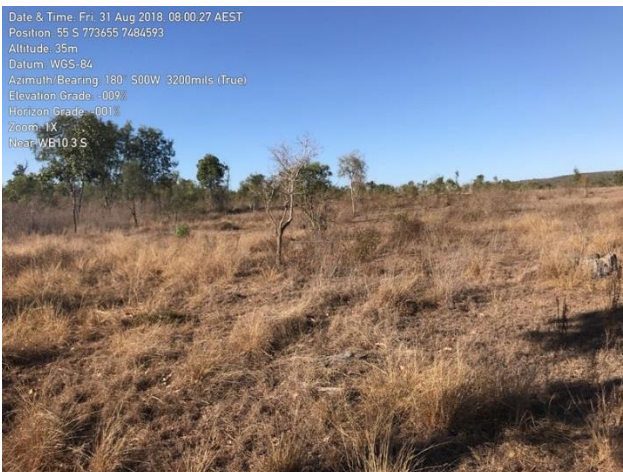
WB10c - looking upstream (south) along gully from survey point

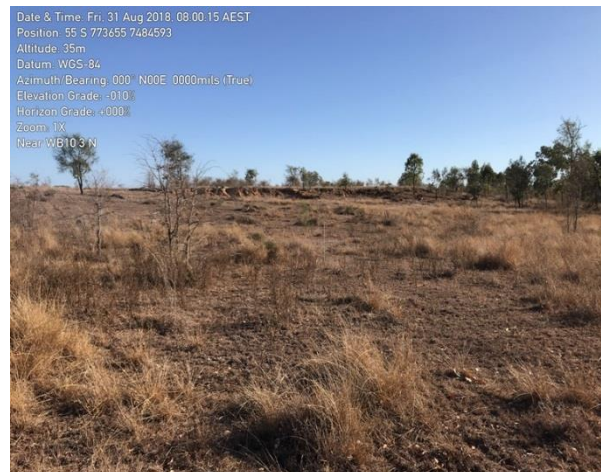
WB10c – looking downstream (north) along gully from survey point

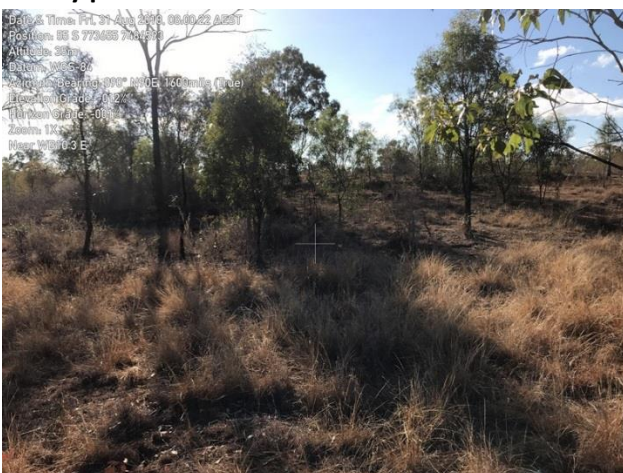
WB10c - looking upstream east across gully from survey point

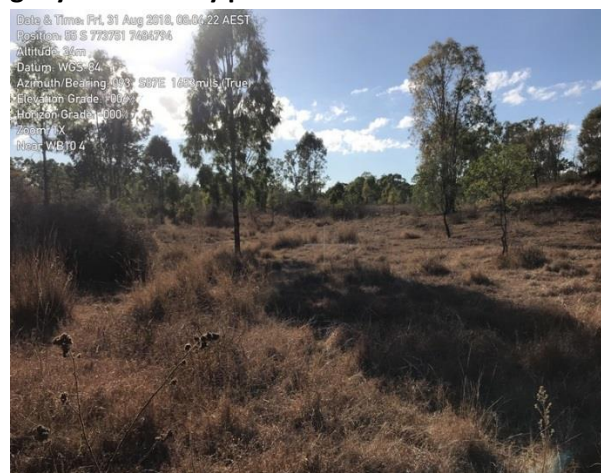
WB10d – looking downstream (east) along gully from survey point

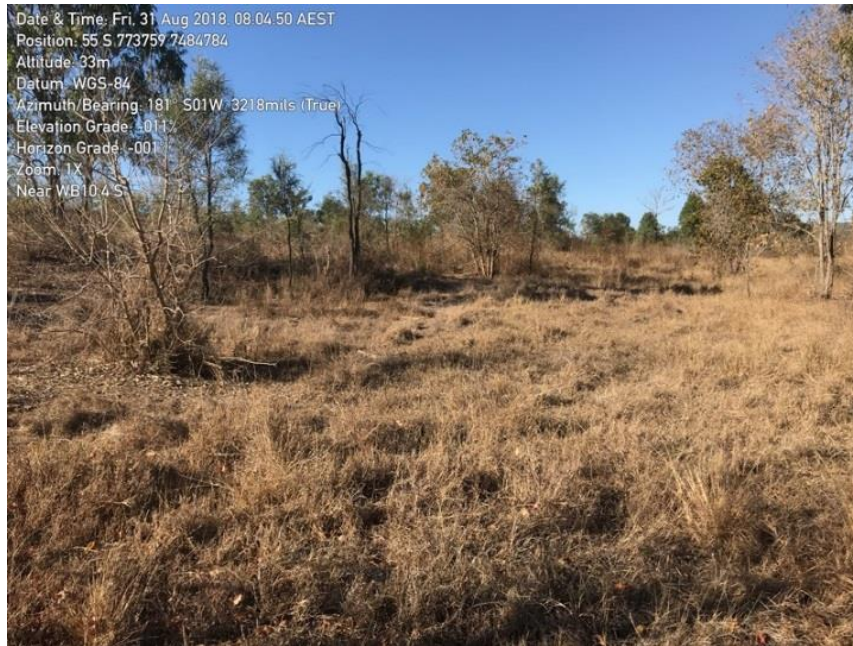
WB10d - looking upstream (south) along gully from survey point

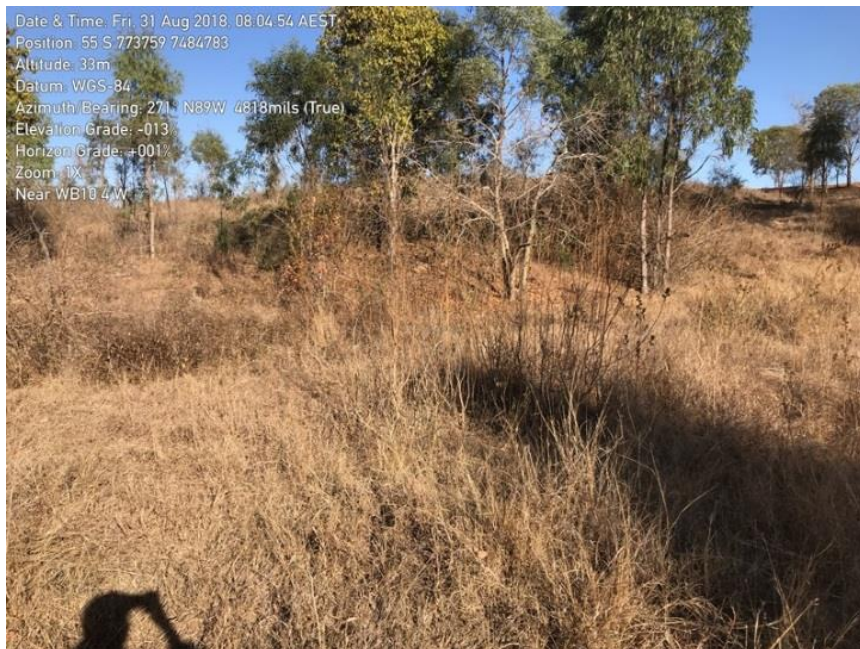
WB10d – looking upslope (west) from gully survey point showing lack of bank

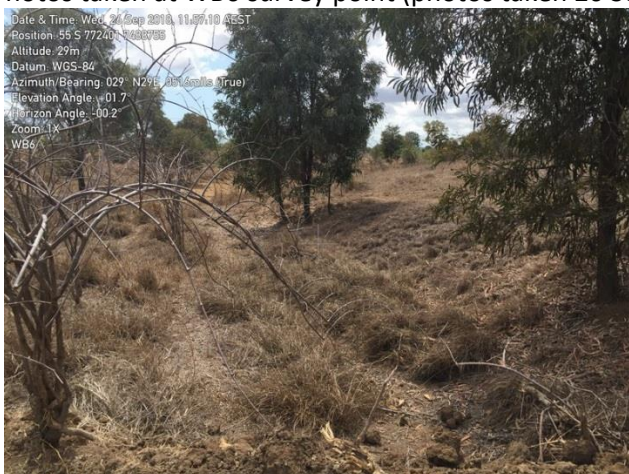
Photo looking north (upstream) from WB6 showing channel depression with no defined banks

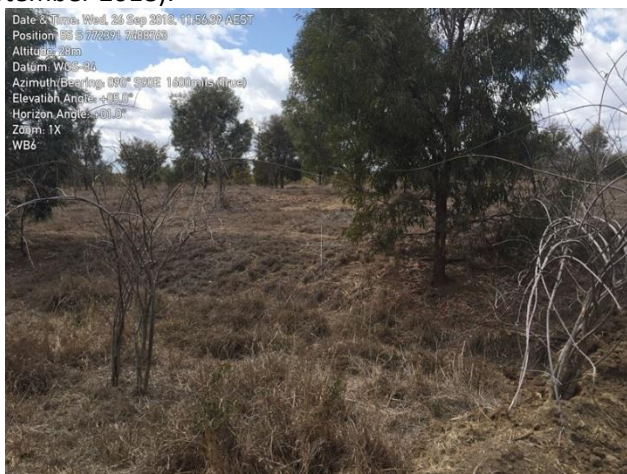
Photo looking east from WB6 from channel

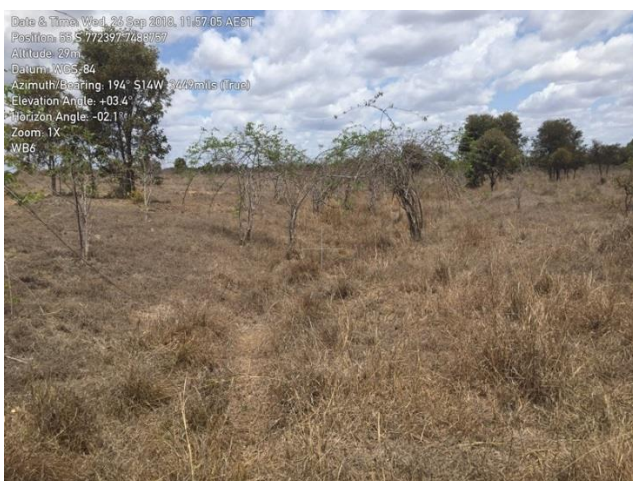
Photo looking south (downstream) from WB6 showing channel depression with no defined banks

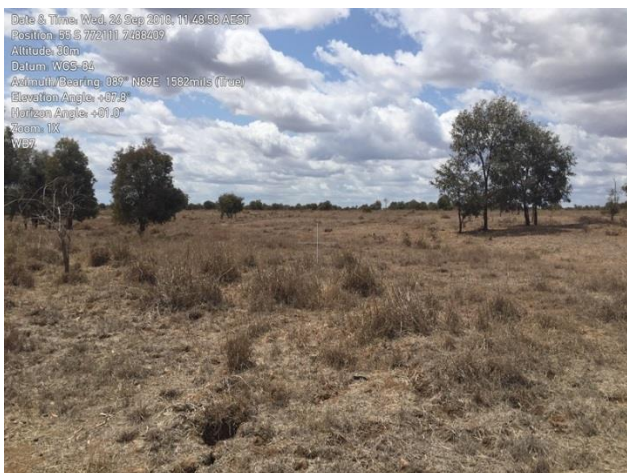
Photos taken at WB7 survey point – slight channel present (photos taken 26 September 2018)

Photo looking east from WB7

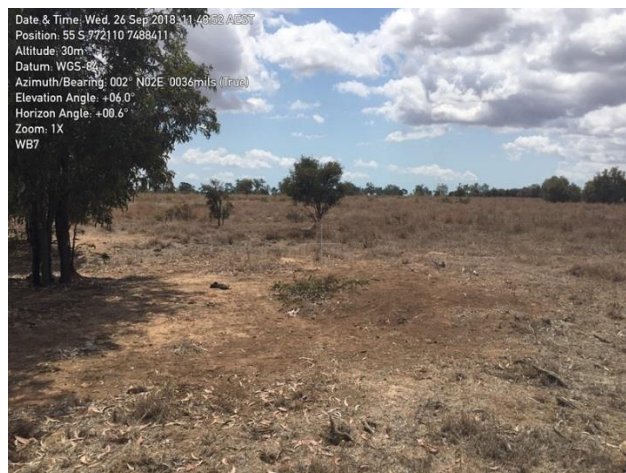
Photo looking north from WB7

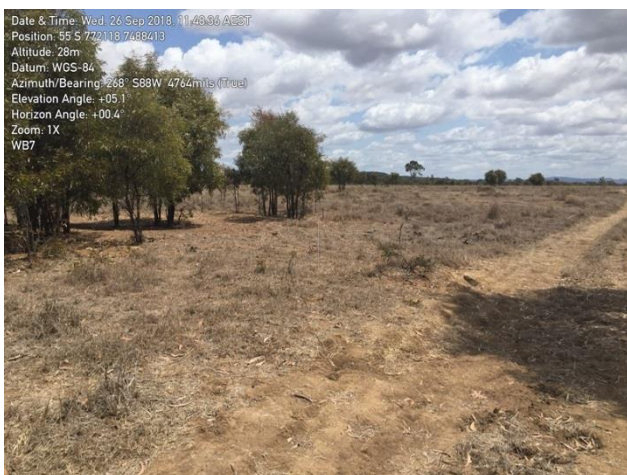
Photo looking west from WB7

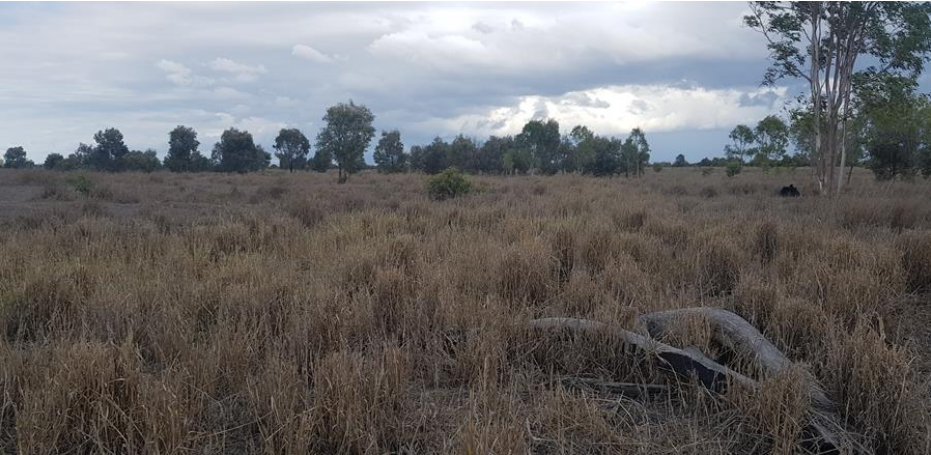
Photos taken at WB3 – no channel indicated in any view, reduced to landscape depression (photos taken 31 October 2018)

Photo looking north-east along channel/depression from WB3

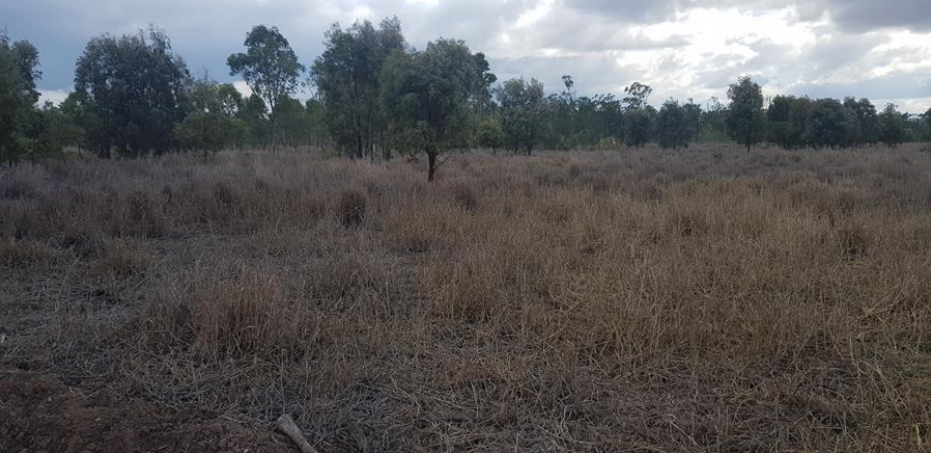
Photo looking south-west along channel/depression from WB3

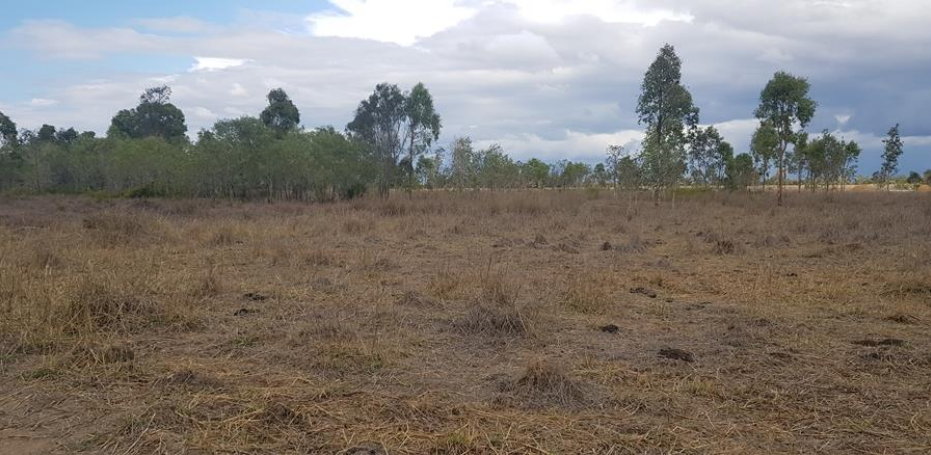
Photos taken at WB1 – no channel indicated in any view, reduced to landscape depression (photos taken 31 October 2018)

Photo looking east along channel/depression from WB1

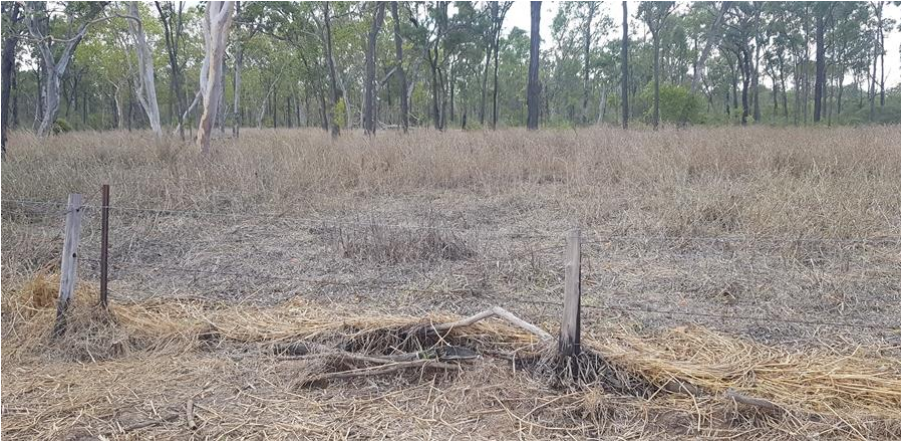
Photo looking west along channel/depression from WB1

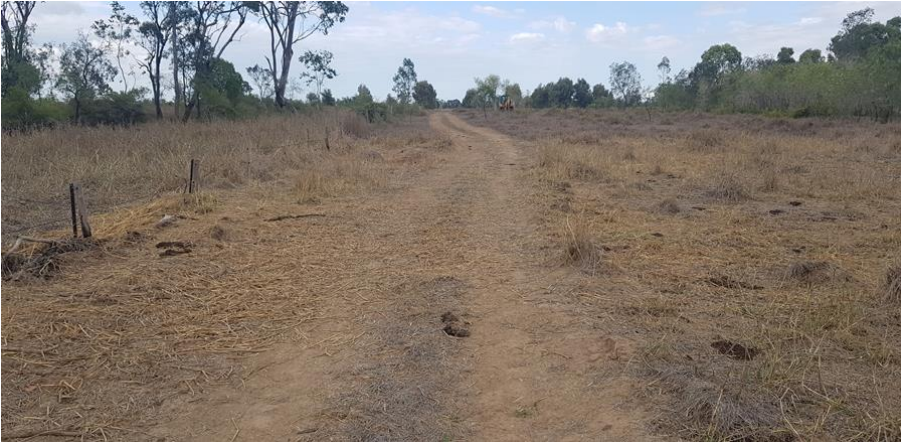
Photo looking north from WB1 with no bank visible

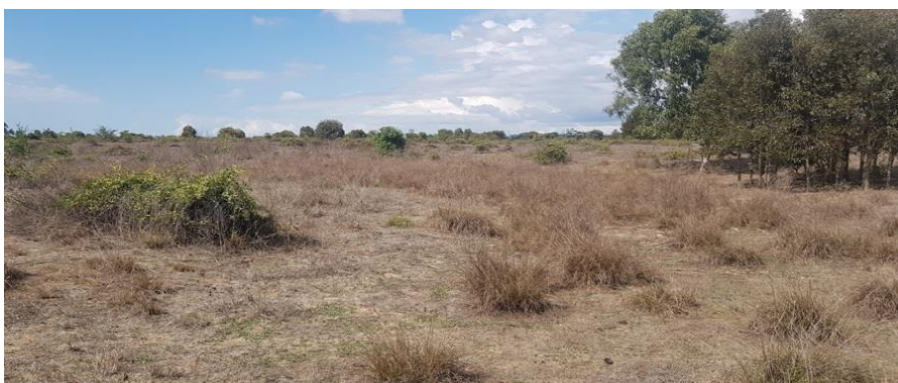
Photos taken at WB2 – very minor channel reduced to landscape depression. No banks visible in photos (photos taken 31 October 2018).

Photo looking north-east upstream along channel/depression from WB2

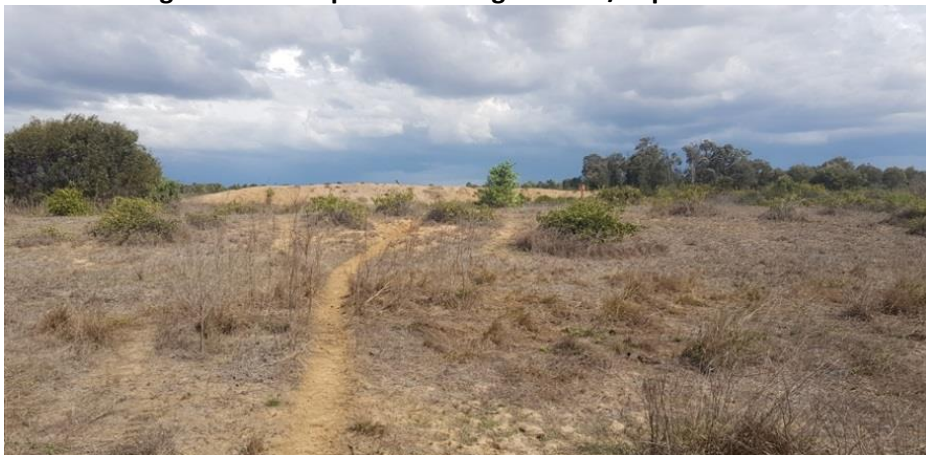
Photo looking south from WB2 towards dam wall

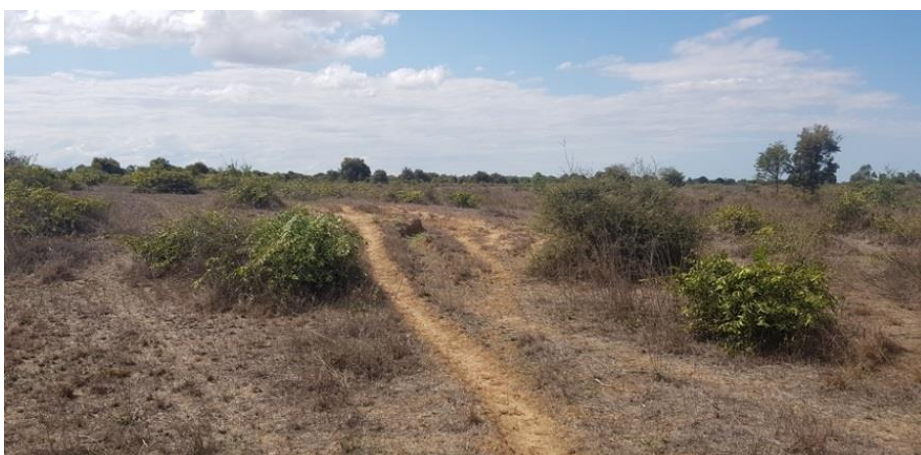
Photo looking west toward channel edge from WB2

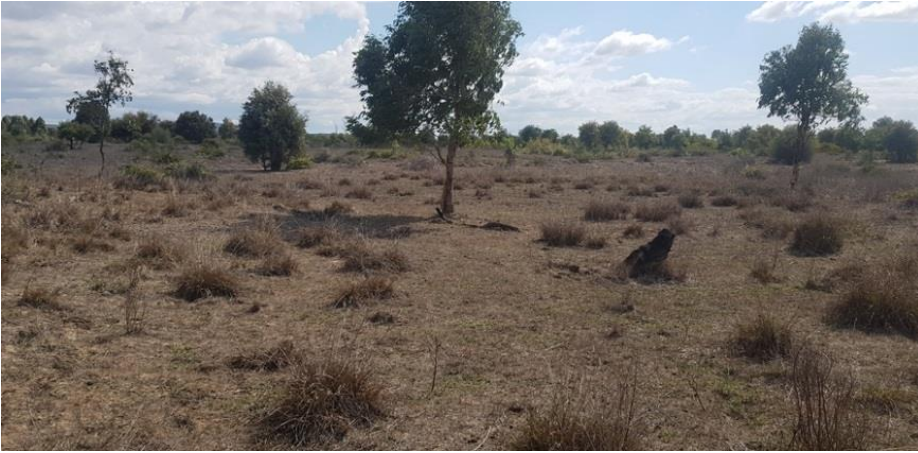
Photo looking east toward channel edge from WB2

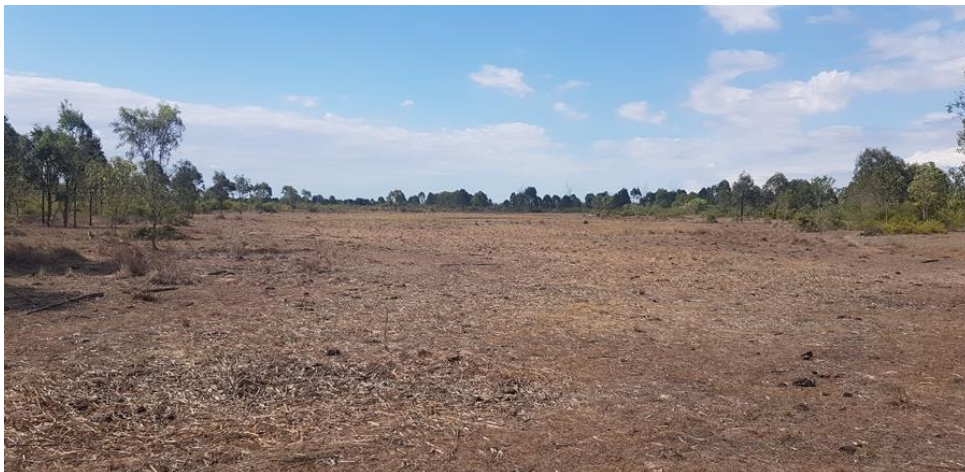
Photos taken at WB4 – no formed channel and reduced to wide landscape depression (photos taken 31 October 2018).

Photo looking north upstream along depression from WB4

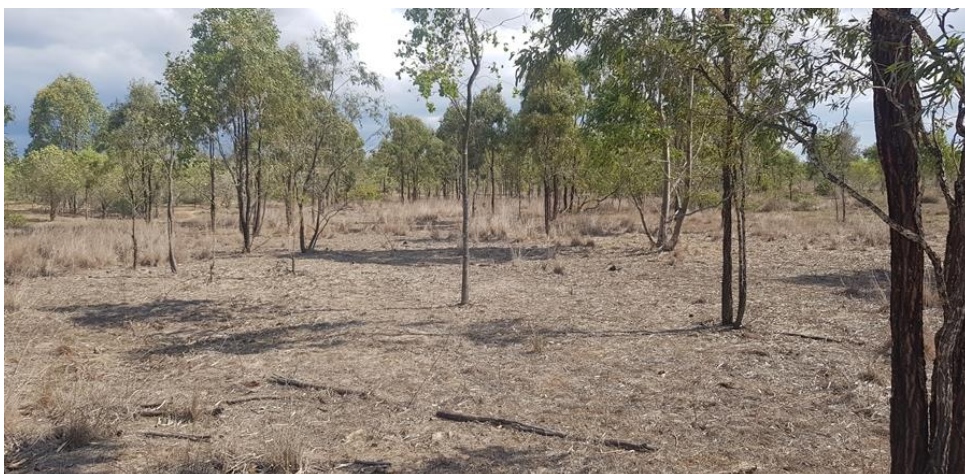
Photo looking south downstream along depression from WB4

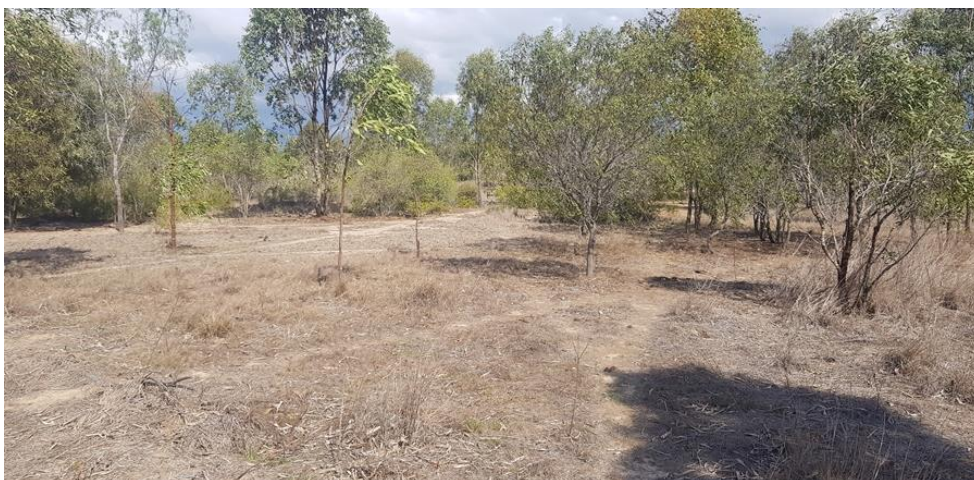
Photo looking east from WB4
