Central Queensland Coal Project

Appendix 21 - Waterway Barrier Works Assessment

**Supplementary
Environmental Impact
Statement**

Review of waterway barrier works mapping intersecting the Central Queensland Coal Project (ML80187)

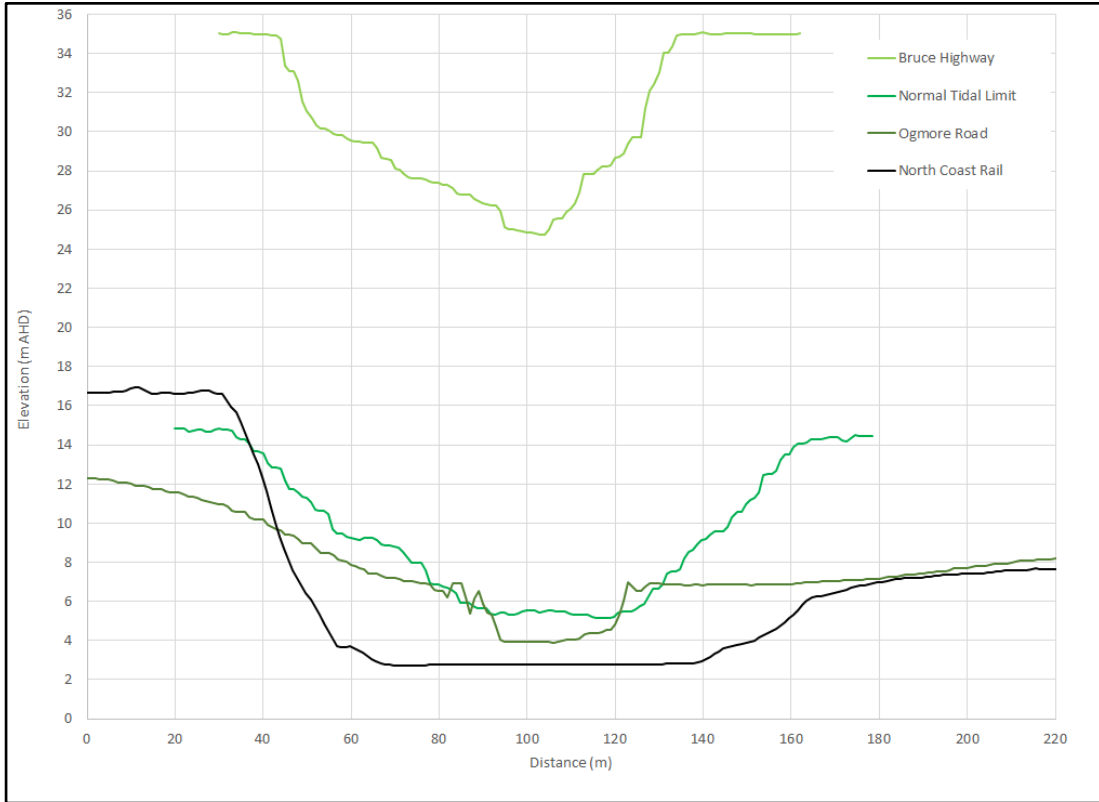
Figure 2 Comparative cross-section of watercourse crossings in area from LIDAR (Deep Creek shown at top)

The mapped drainage features sit on the Deep Creek floodplain and outside the effective flow area. The catchment area of the subject waterways is small and topography relatively flat. Deep Creek itself is a steeply incised channel and highly ephemeral. Figure 2 below shows the channel of Deep Creek is approximately 10 m below the adjacent bank height where the Bruce Highway crosses the creek (based on recent LIDAR survey).

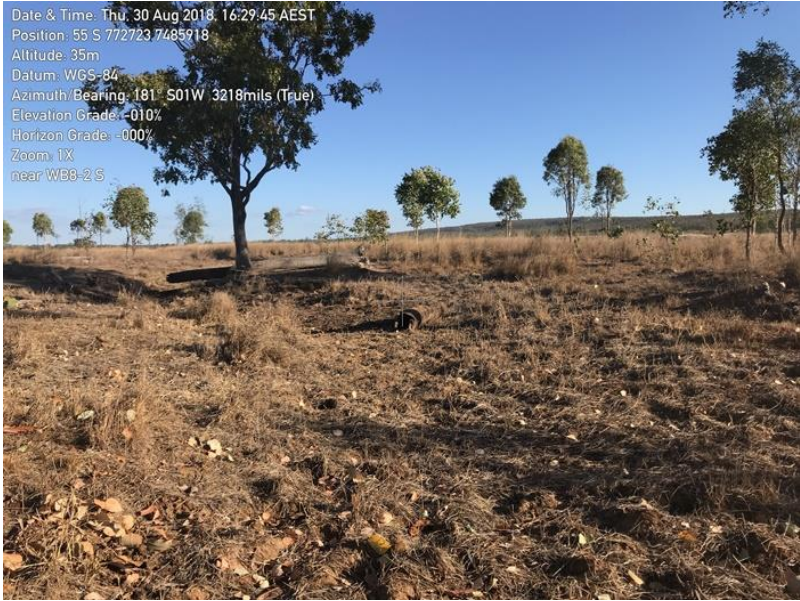
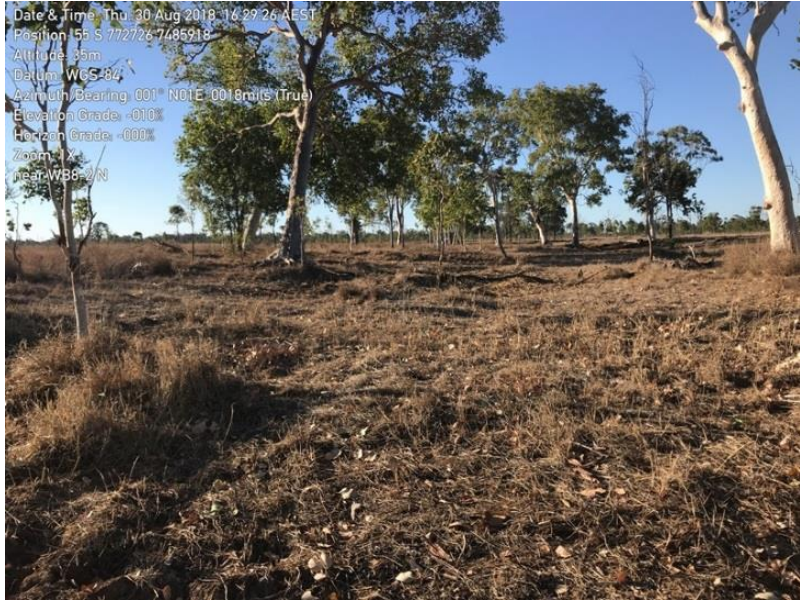
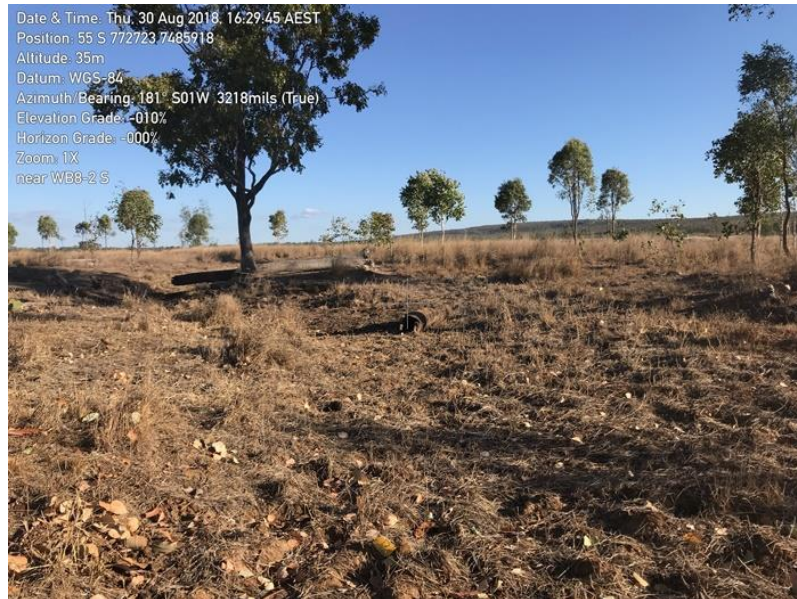
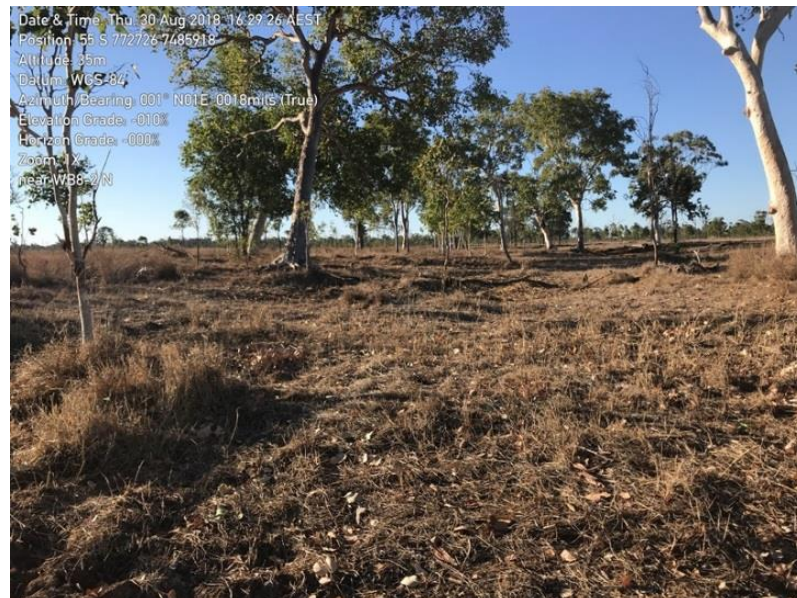
Photos taken at WB8c point – depression observed but no discernible channel indicated in either view

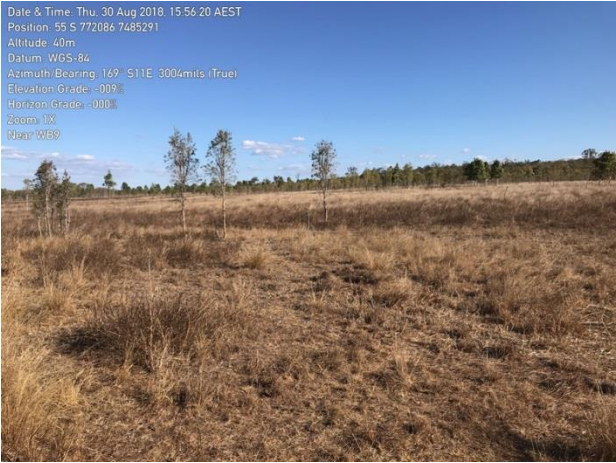
The following photos depict a point located upstream and south-west of the bermed areas. The point is located near a farm dam adjacent to a mapped 'low risk' waterway (indicated on Figure A1 as survey point WB9). Aerial imagery indicates a low overflow area emanating from the dam at this point. However, there is no 'channel' indicated in the site photos or on aerial imagery.

WB9 - looking north from survey point towards dam

WB9 – looking east from survey point along mapped drainage line

WB9 - looking south from survey point

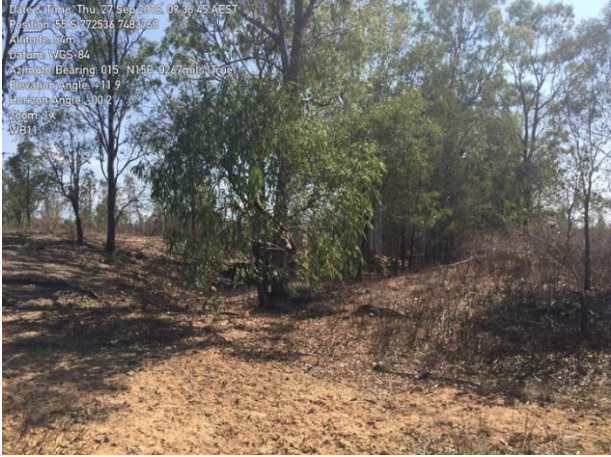
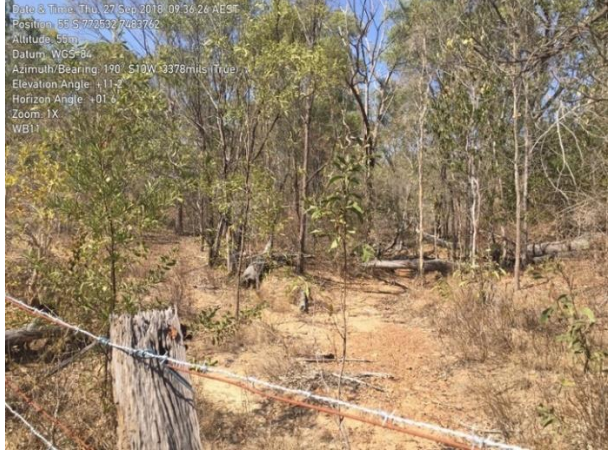
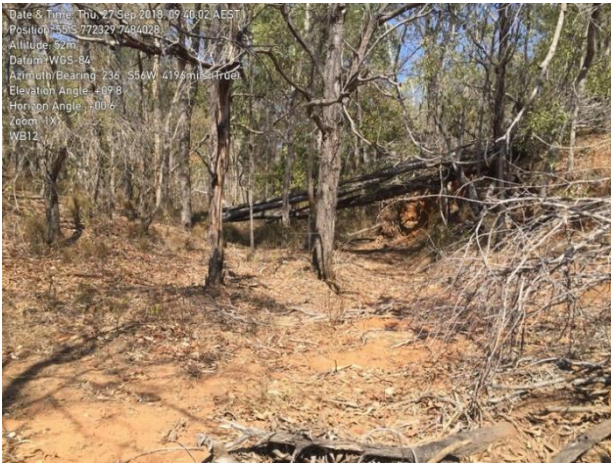
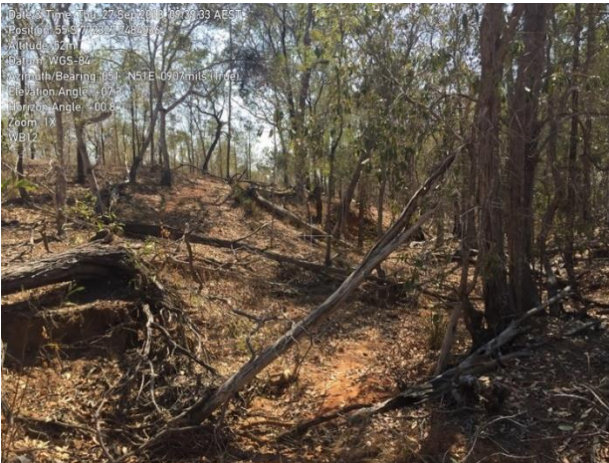
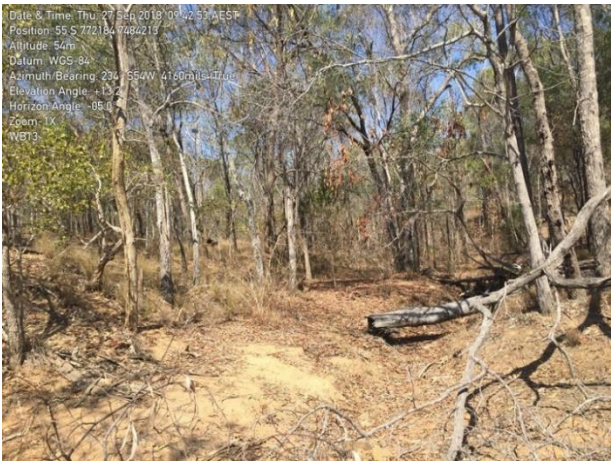
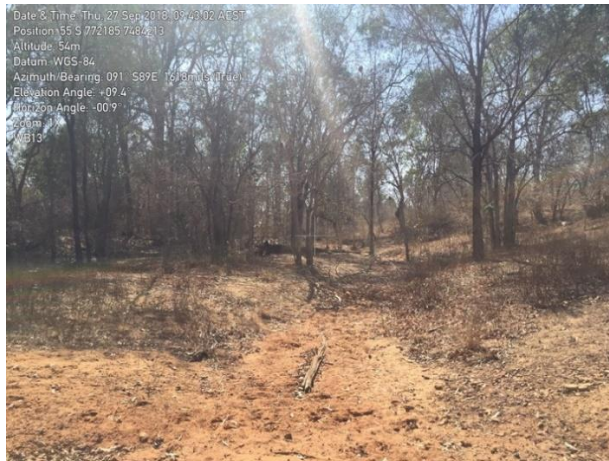
The following photos depict points located along 'low risk' waterways (indicated on Figure A1 as survey points WB11, WB12 and WB13) located upstream of the bermed areas and survey points WB8a-d. These waterways drain a low rocky hill/plateau and are highly ephemeral. The photos indicate very minor channelisation (at best described as a drainage area) and do not represent potential or temporary fish habitat. Photos taken 27 September 2018.

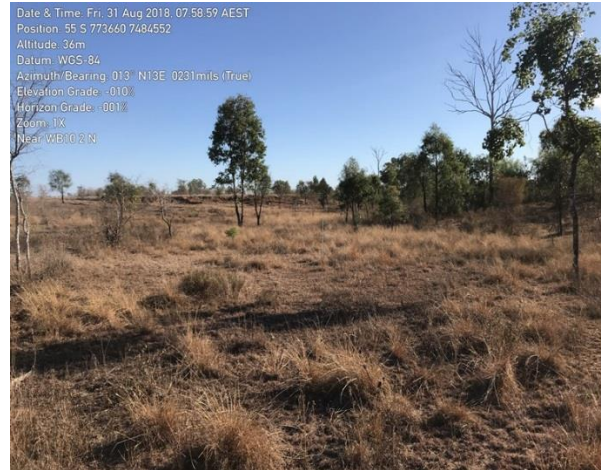
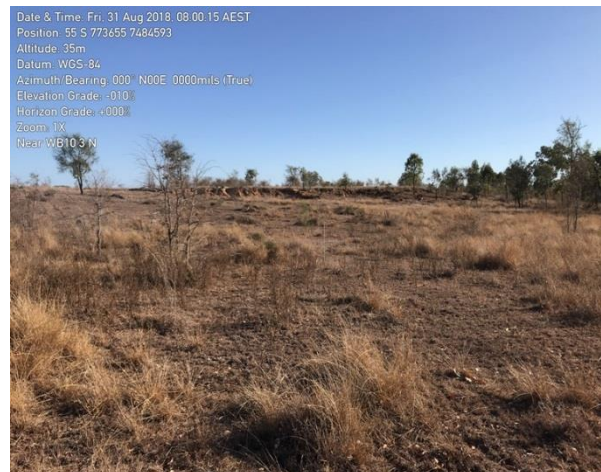
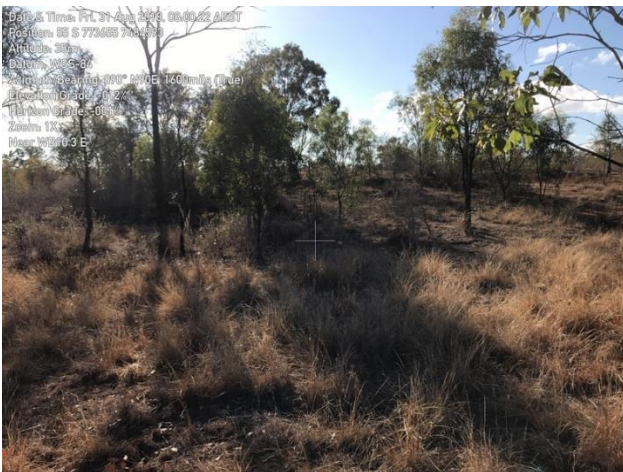
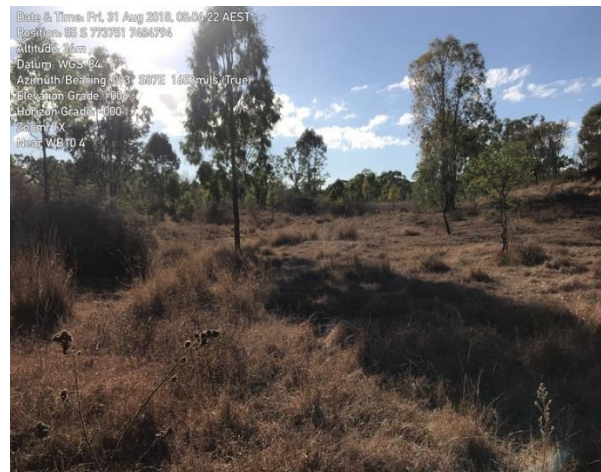
The cross-section to the south of the highway (Figure 4) shows the approximate position of the mapped 'risk' features demonstrating there is no channel at all in these areas. The cross section at WB10c (refer Attachment 1) demonstrates the depth of the feature is 3 m below the surrounding landscape with gentle channel slopes extending across an overall width of over 100 m. There is no evidence of a bank on this feature.

The following depicts a minor channel/gully (described as ‘low risk’ under the mapping) draining a very small catchment which is separate from the catchment described by the previous survey point photos and feeds into Deep Creek (indicated on Figure A1 as survey points labelled WB10a-d). This area comprises a relatively steep eroded gully which does not have any defined bed or banks or provide any potential pooled areas before draining to Deep Creek. There is approximately 260 m between the points depicted - WB10a and WB10d. Photos taken 31 August 2018.

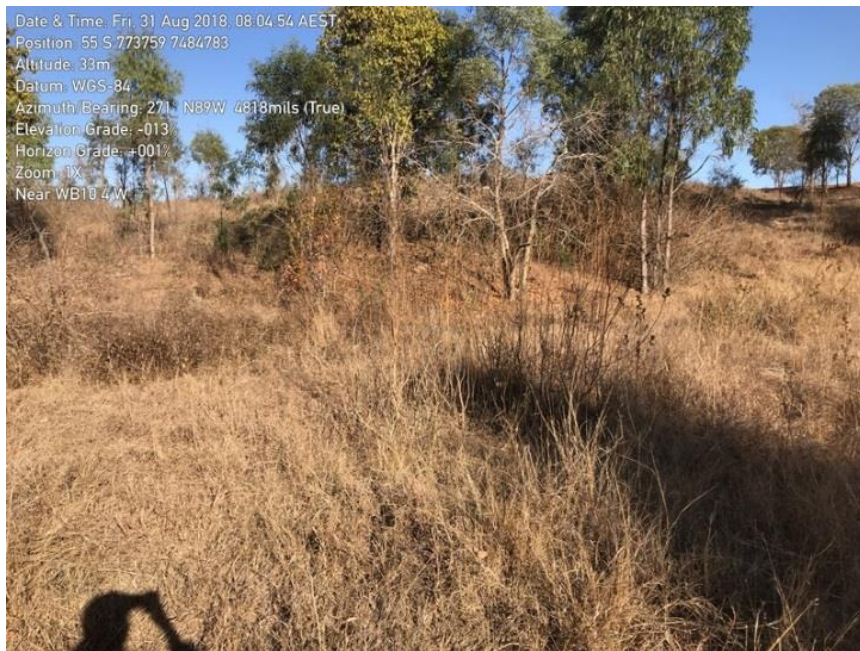
WB10d – looking upslope (west) from gully survey point showing lack of bank

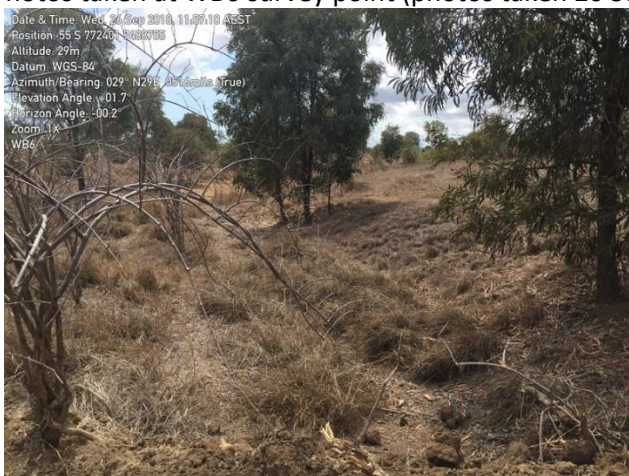
Photo looking north (upstream) from WB6 showing channel depression with no defined banks

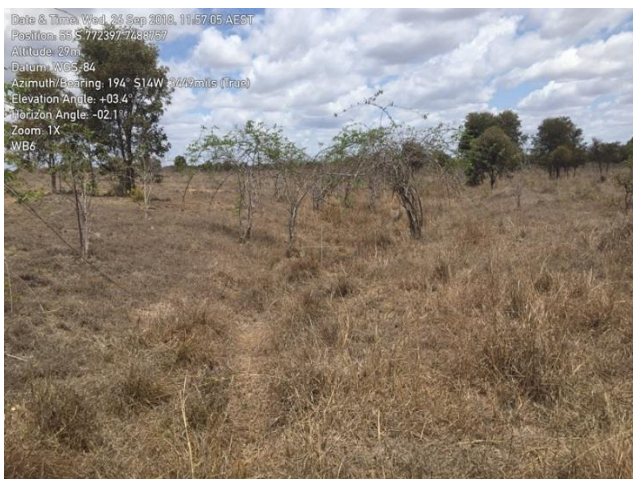
Photo looking south (downstream) from WB6 showing channel depression with no defined banks

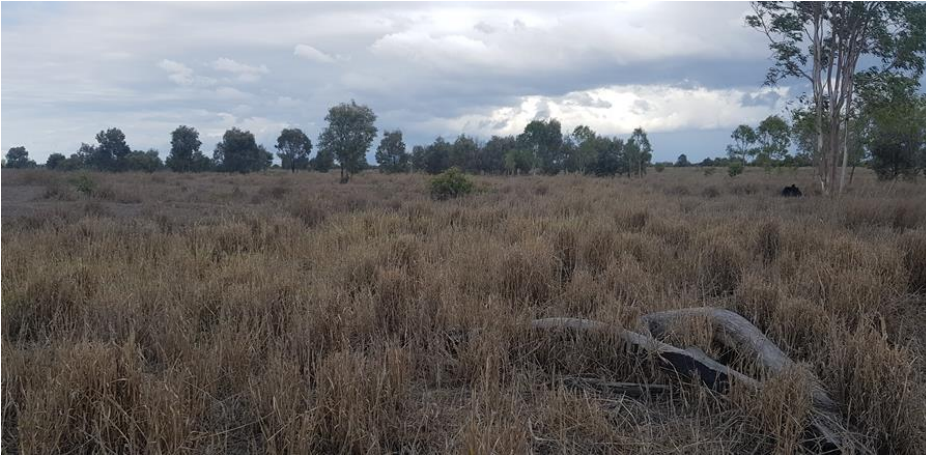
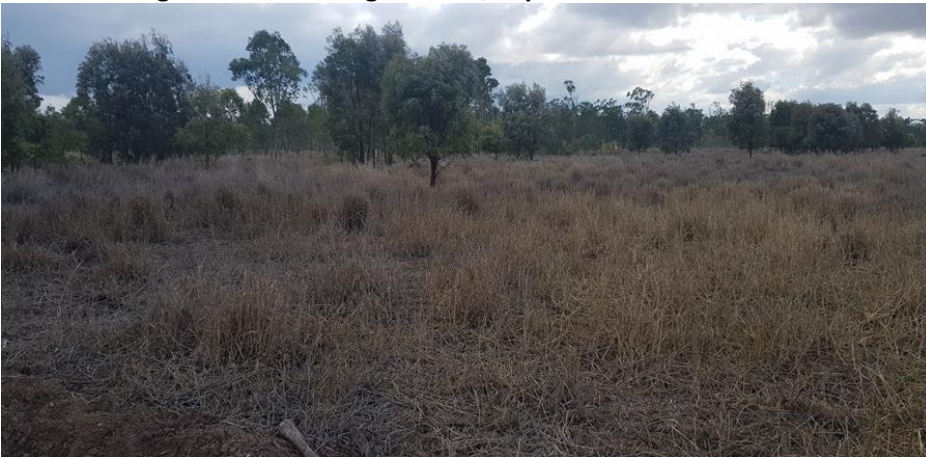
Photos taken at WB3 – no channel indicated in any view, reduced to landscape depression (photos taken 31 October 2018)

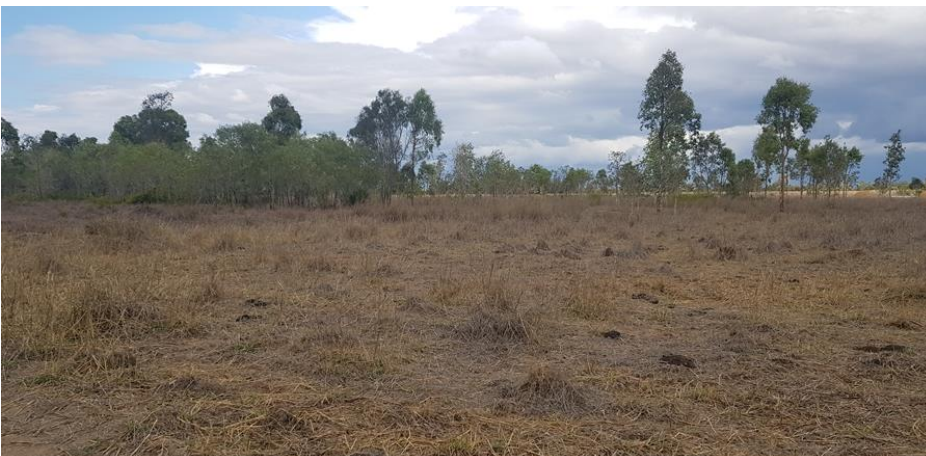
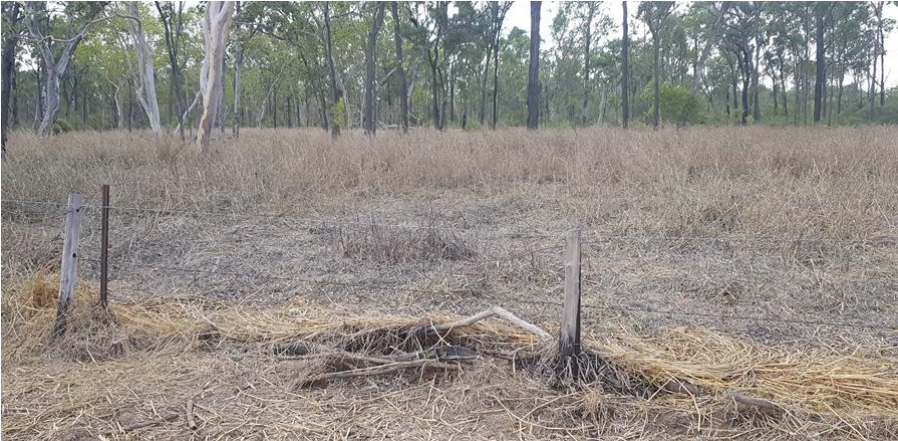
Photos taken at WB1 – no channel indicated in any view, reduced to landscape depression (photos taken 31 October 2018)

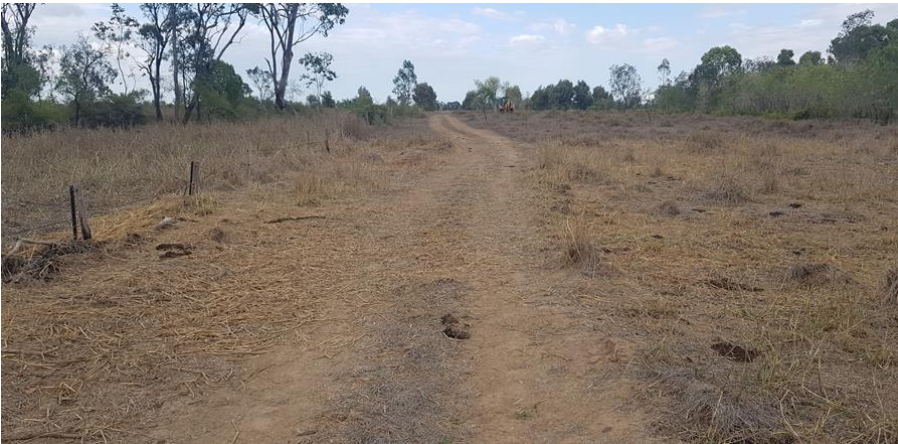
Photo looking north from WB1 with no bank visible

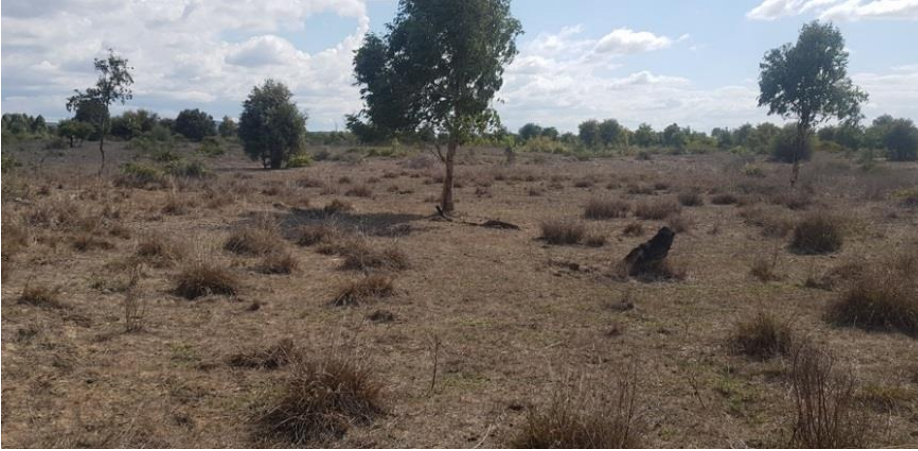
Photos taken at WB2 – very minor channel reduced to landscape depression. No banks visible in photos (photos taken 31 October 2018).

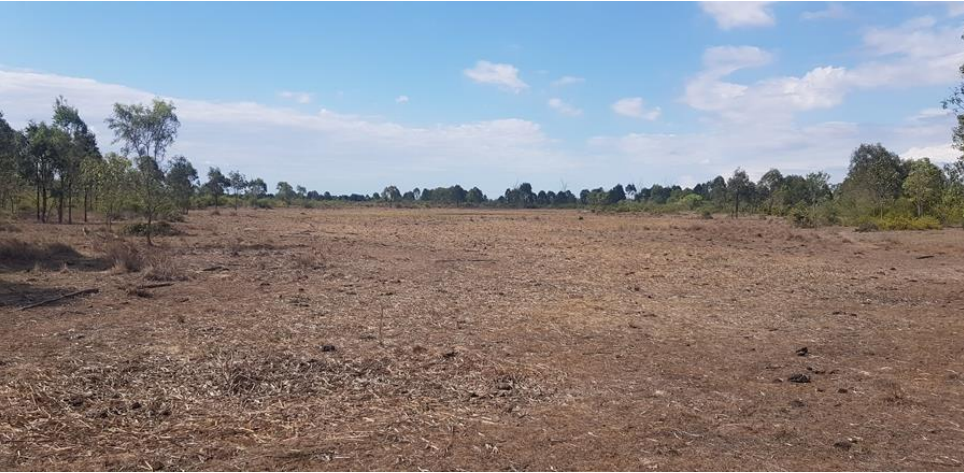
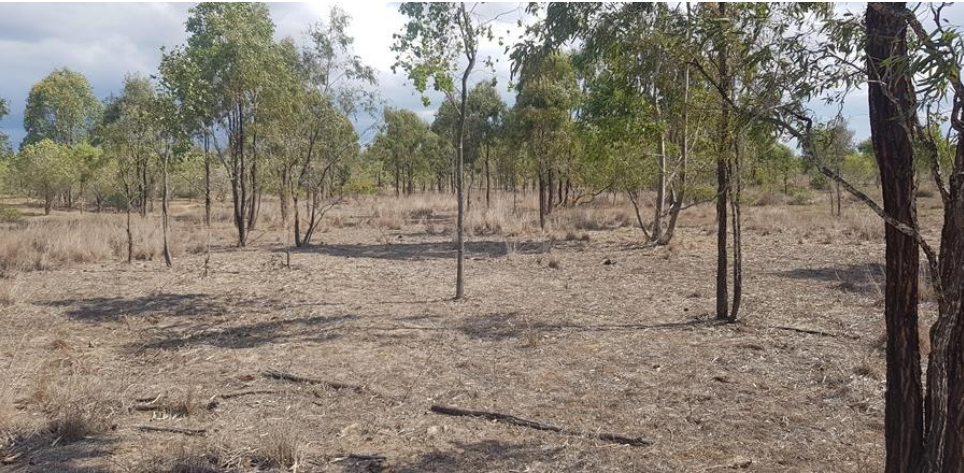
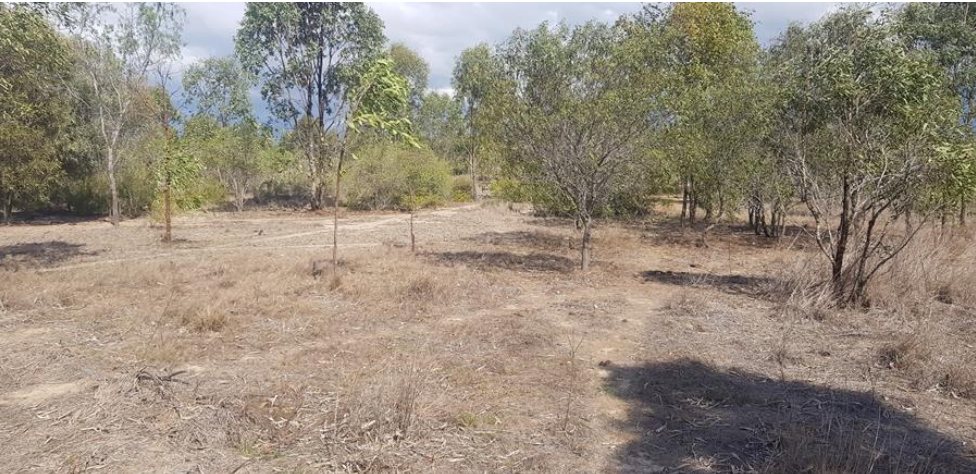
Photos taken at WB4 – no formed channel and reduced to wide landscape depression (photos taken 31 October 2018).
