# **Central Queensland Coal Project**

## **Appendix 4b – Geotechnical Assessment**

# Detailed Geotechnical Assessment and Stability Report

Central Queensland Coal Project

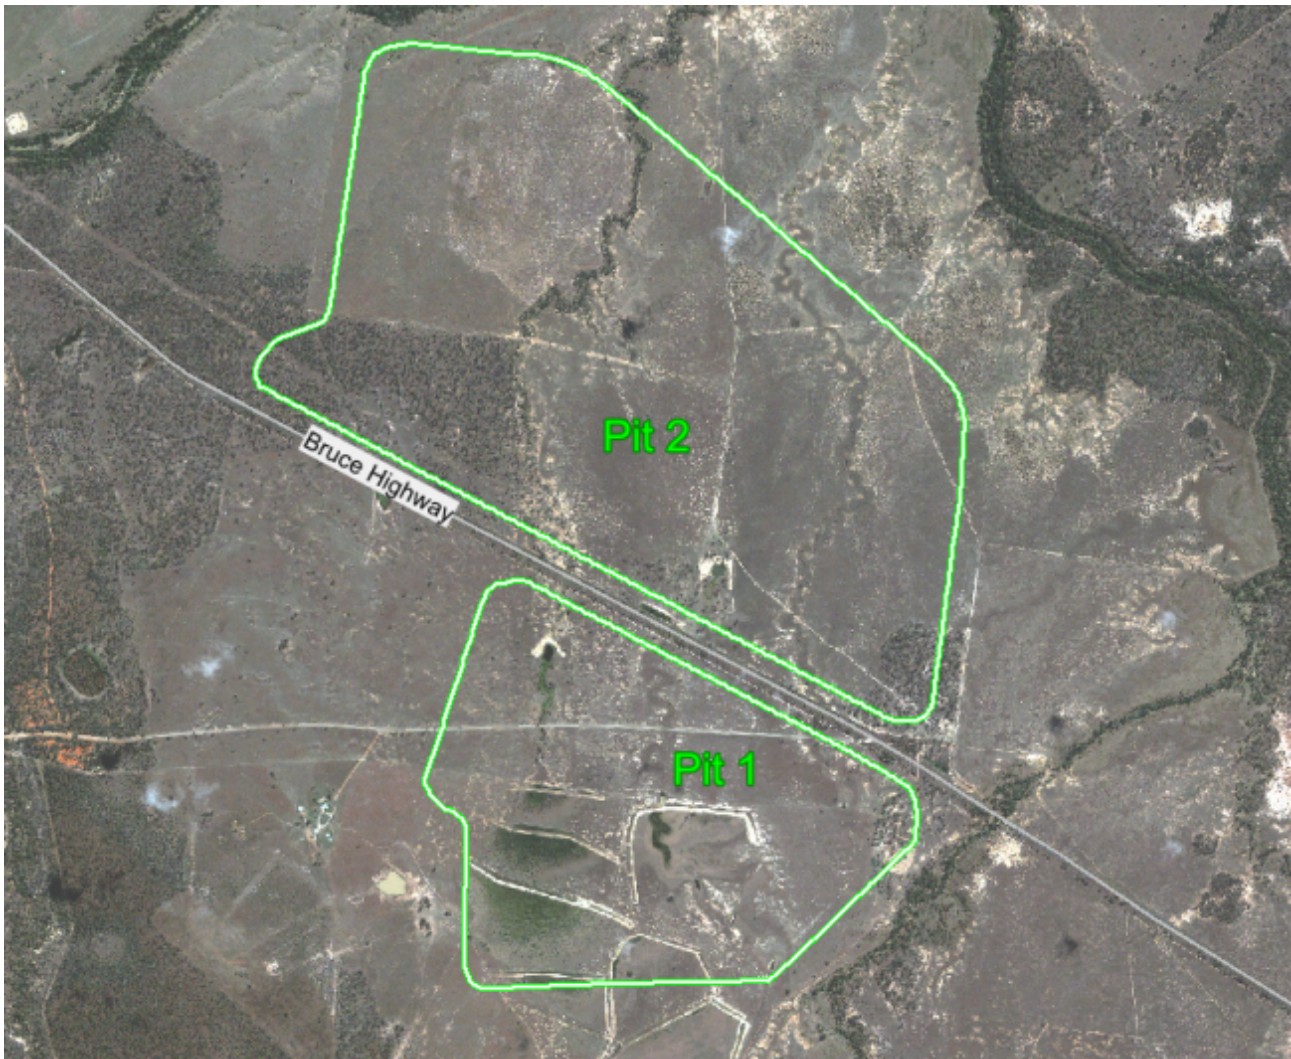
Figure 1-1 Project Location

This report presents the results of a report on pit stability and likely ground movements associated with proposed mining works approximately 25km northwest of Marlborough, Central Queensland (Refer Figure 1-1). The proposed works comprise the excavation and backfilling of coal mine pits on either side of the Bruce Highway, however, this report is concerned with pit excavations on the northeast side of the highway only.

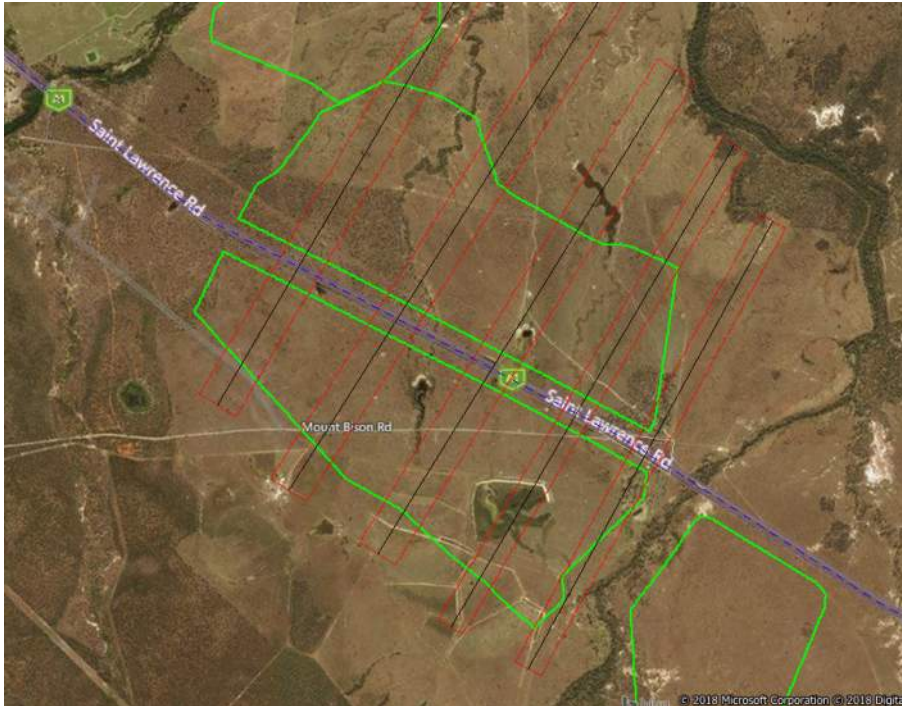
Figure 1-1 Project Location

This report provides a desktop study of pit stability and likely ground movements associated with proposed mining works approximately 25km northwest of Marlborough, Central Queensland (Refer Figure 1-1). The proposed works comprise the excavation and re-filling of coal mine pits on either side of the Bruce Highway.

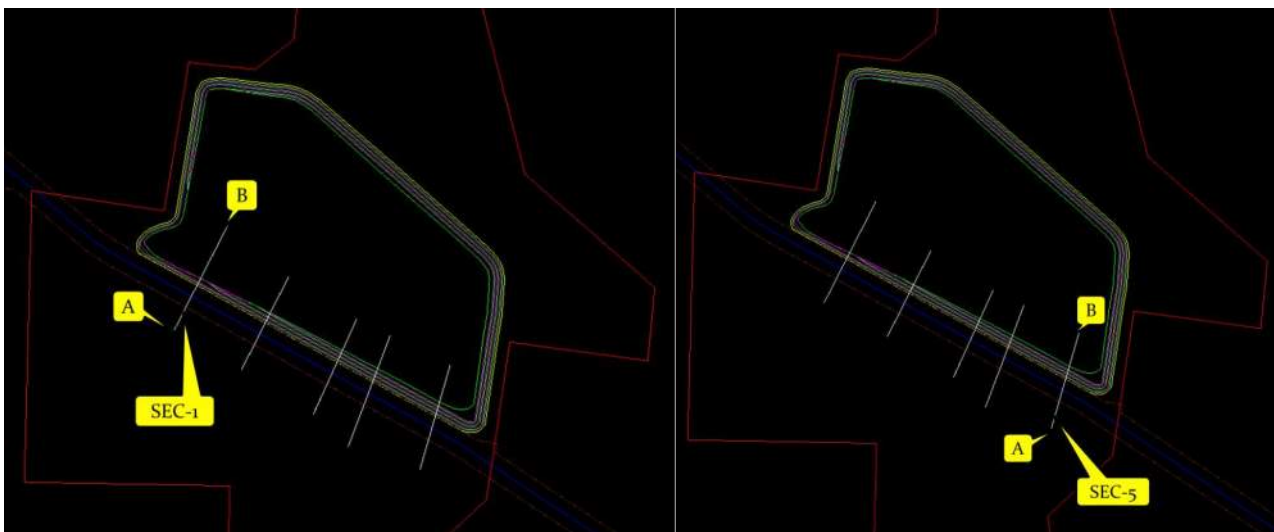
Figure 3-1 Location of Cross Sections

A total of five cross sections were provided as shown in Figure 3-1. Stability and deformation models were prepared for Cross Section 5 which had the deepest proposed excavation (Refer Figure 3-2 and Figure 3-3).

1. Initial sketches provided by George Klenowski (Refer Figure 2-1)
2. Cross Sections with mapped coal layers provided by Michael McShane
3. Cross Sections with revised coal layers provided by Adriaan Benson (Refer Figure 3-1)

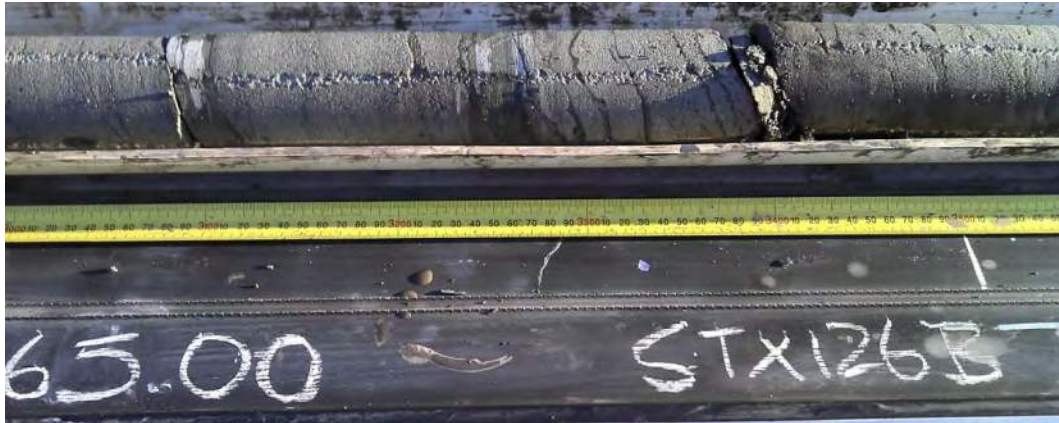
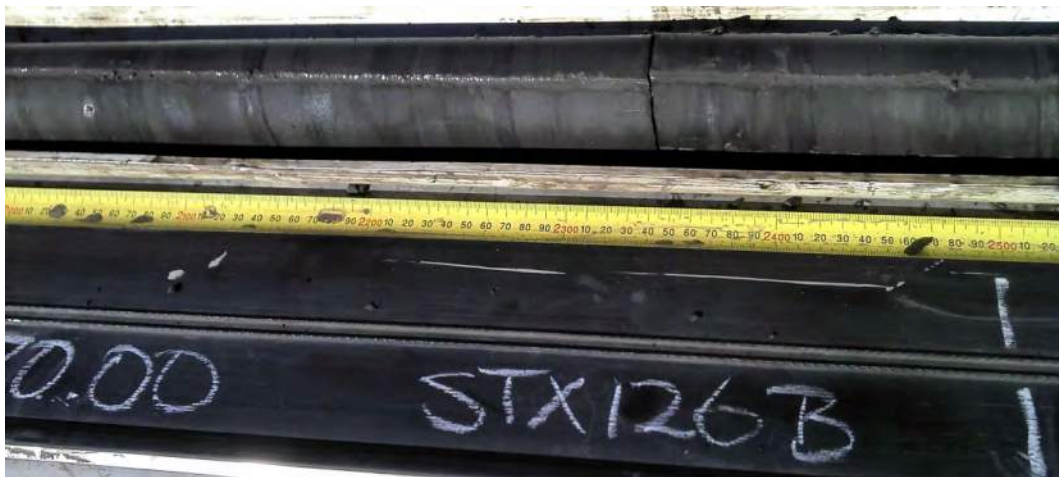
CLIENT : <b>CENTRAL QUEENSLAND COAL PTY LTD</b>	CORE TYPE:	LOCATION E 771 431.56 N 7 487 323.69	BOREHOLE No: STX127 SHEET 1 OF 4
	CASING DEPTH:		
SITE LOCATION / PURPOSE : <b>NEXT TO BRUCE HIGHWAY, GEOTECHNICAL ASSESSMENT</b>	WATER TABLE DEPTH: LEVEL:	GROUND LEVEL (AHD) 37.23	DRILLING DATE: 13/05/11

DESCRIPTION OF CORE ROCK TYPE, COLOUR, GRAIN SIZE	METRES R.L. DEPTH	GRAPHIC LOG	DUR- ABILITY %	STRUCTURES JOINTS, BEDDING, VEINS, SEAMS, CRUSHED ZONES, FAULTS	FRAC. PER METRE	R.Q.D.	SONIC DERIVED UNIAXIAL COMPRESSIVE STRENGTH (MPa)				
							20	40	60	80	100
SOIL, brown				<b>INDETERMINATE</b>			No sonic log				
CLAY, red to brown	4.00 5										
SANDSTONE, brown, highly weathered	14.47 15										
SILTSTONE, dark grey, SANDSTONE, grey, fresh, very weak	16.82 17.61			← Base of weathering 16.82							
Coal	18.57										
Core loss	19.61 20

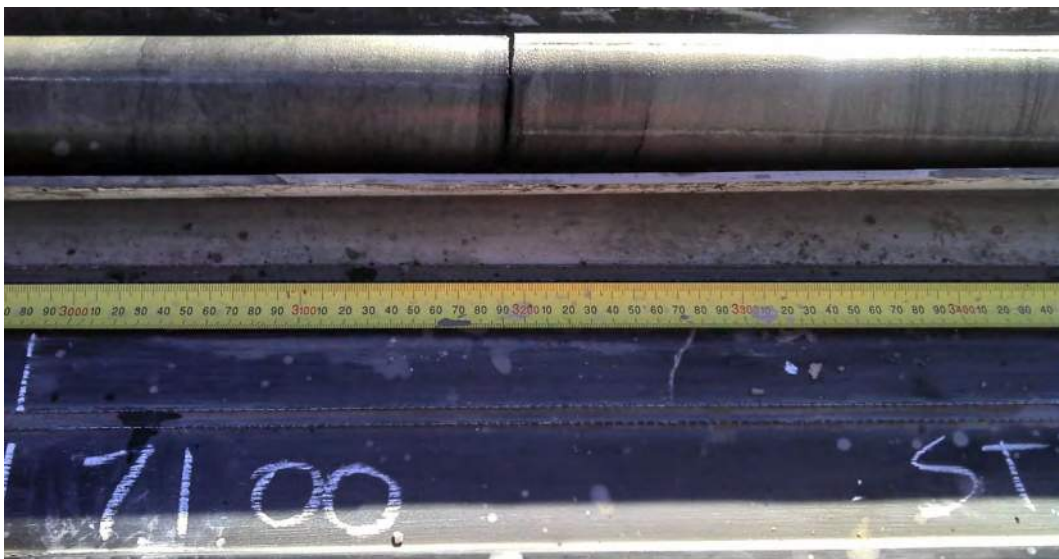
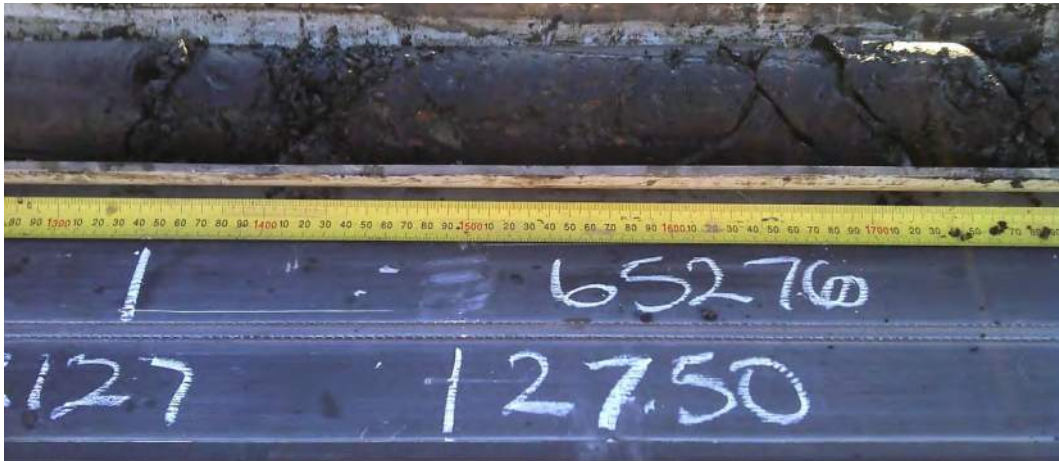
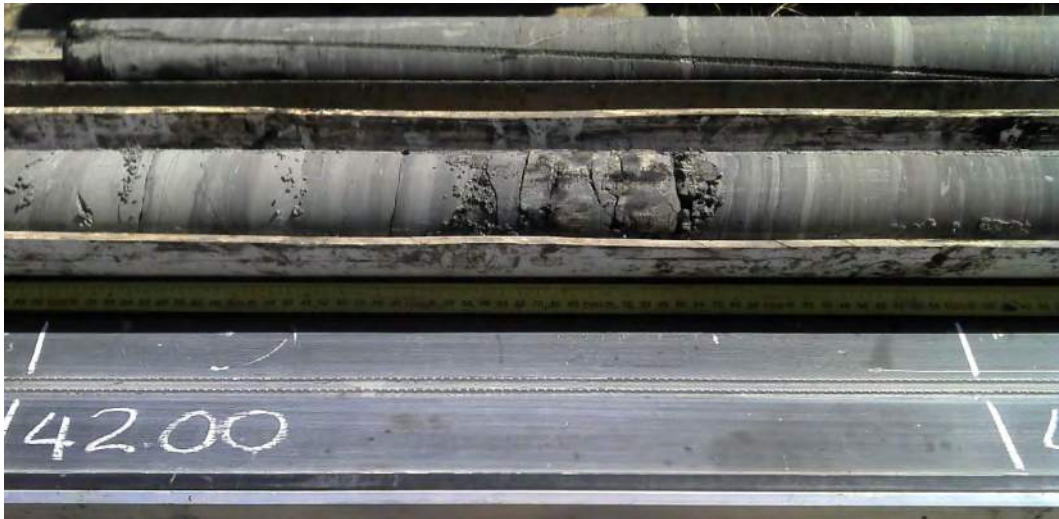
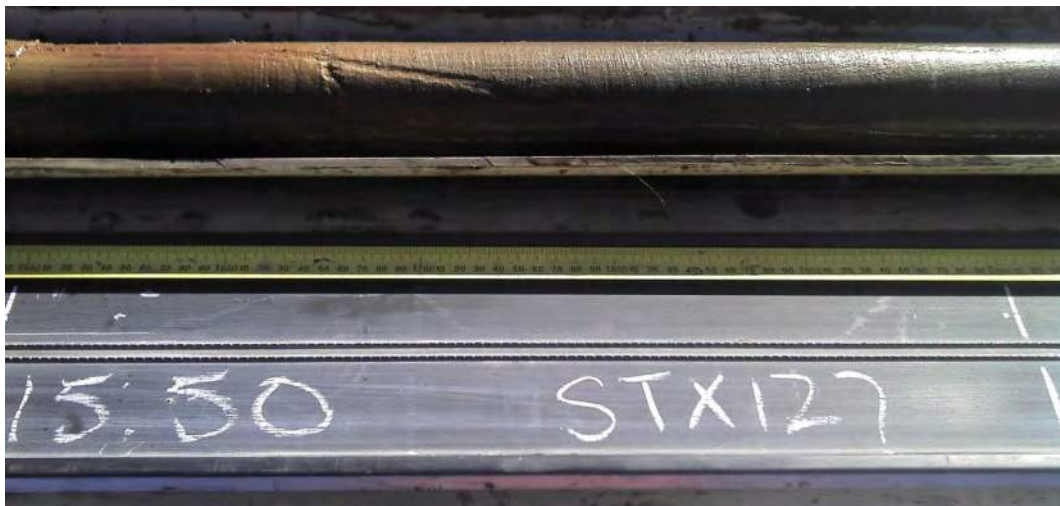
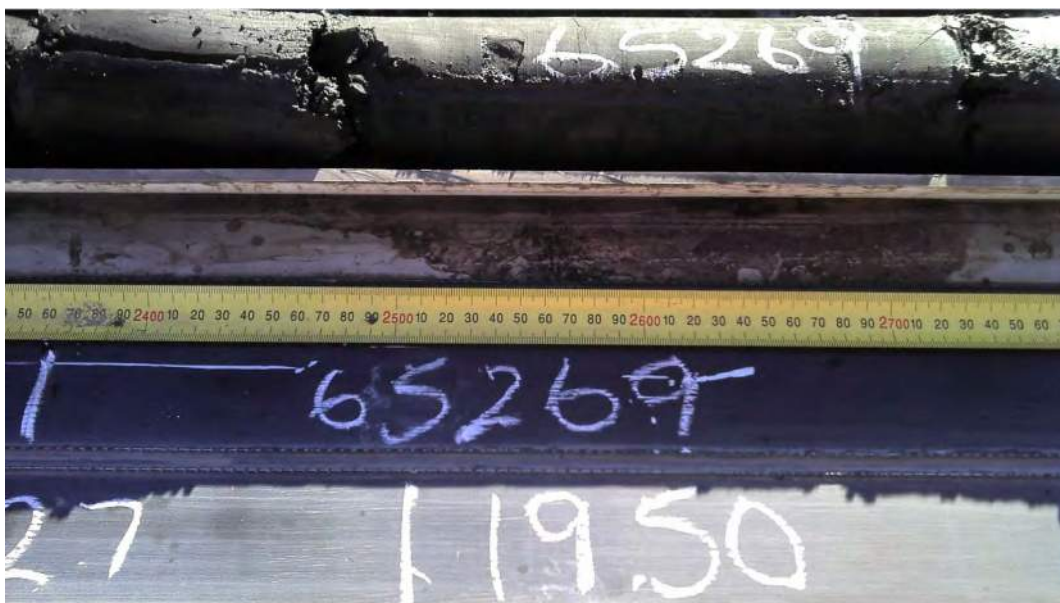
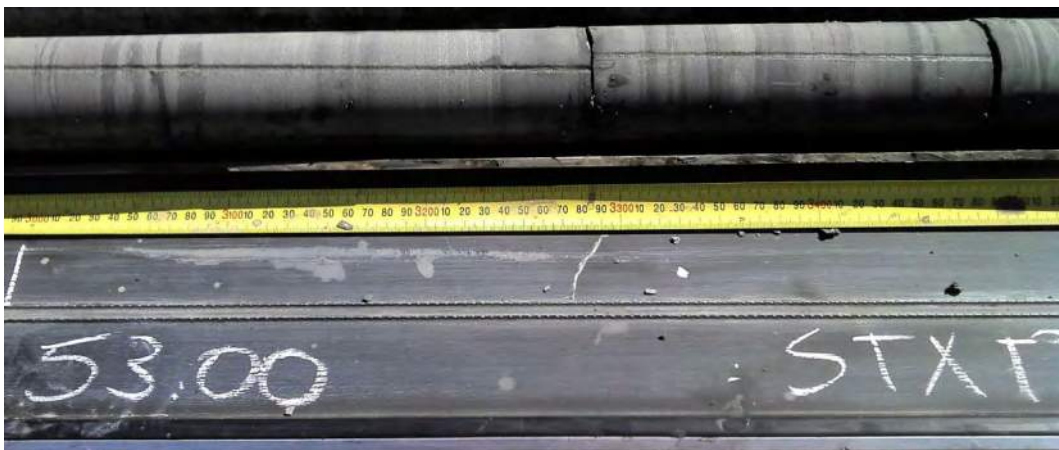
CLIENT : <b>CENTRAL QUEENSLAND COAL PTY LTD</b>	CORE TYPE:	LOCATION E 772 585.31 N 7 486 943.74	BOREHOLE No: STX132C
	CASING DEPTH:		SHEET 1 OF 4
SITE LOCATION / PURPOSE : <b>NEXT TO BRUCE HIGHWAY, GEOTECHNICAL ASSESSMENT</b>	WATER TABLE DEPTH: LEVEL:	GROUND LEVEL (AHD) 31.50	DRILLING DATE: 04/06/11

DESCRIPTION OF CORE ROCK TYPE, COLOUR, GRAIN SIZE	METRES R.L. DEPTH	GRAPHIC LOG	DUR- ABILITY %	STRUCTURES JOINTS, BEDDING, VEINS, SEAMS, CRUSHED ZONES, FAULTS	FRAC. PER METRE	R.Q.D.	SONIC DERIVED UNIAXIAL COMPRESSIVE STRENGTH (MPa)				
							20	40	60	80	100
Not logged

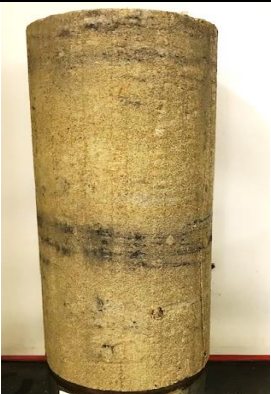
(c) Mixed mode

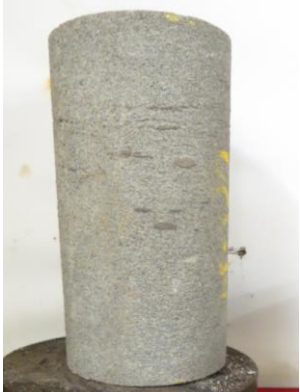
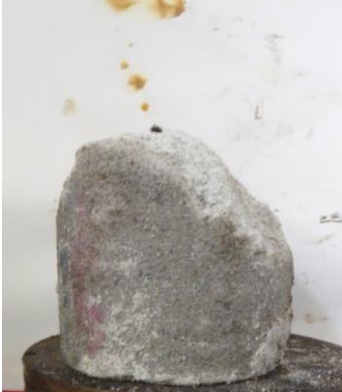
(c) Mixed mode

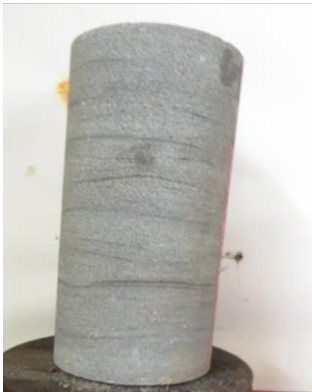
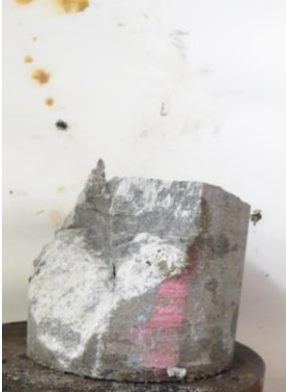
(a) Single shear plane

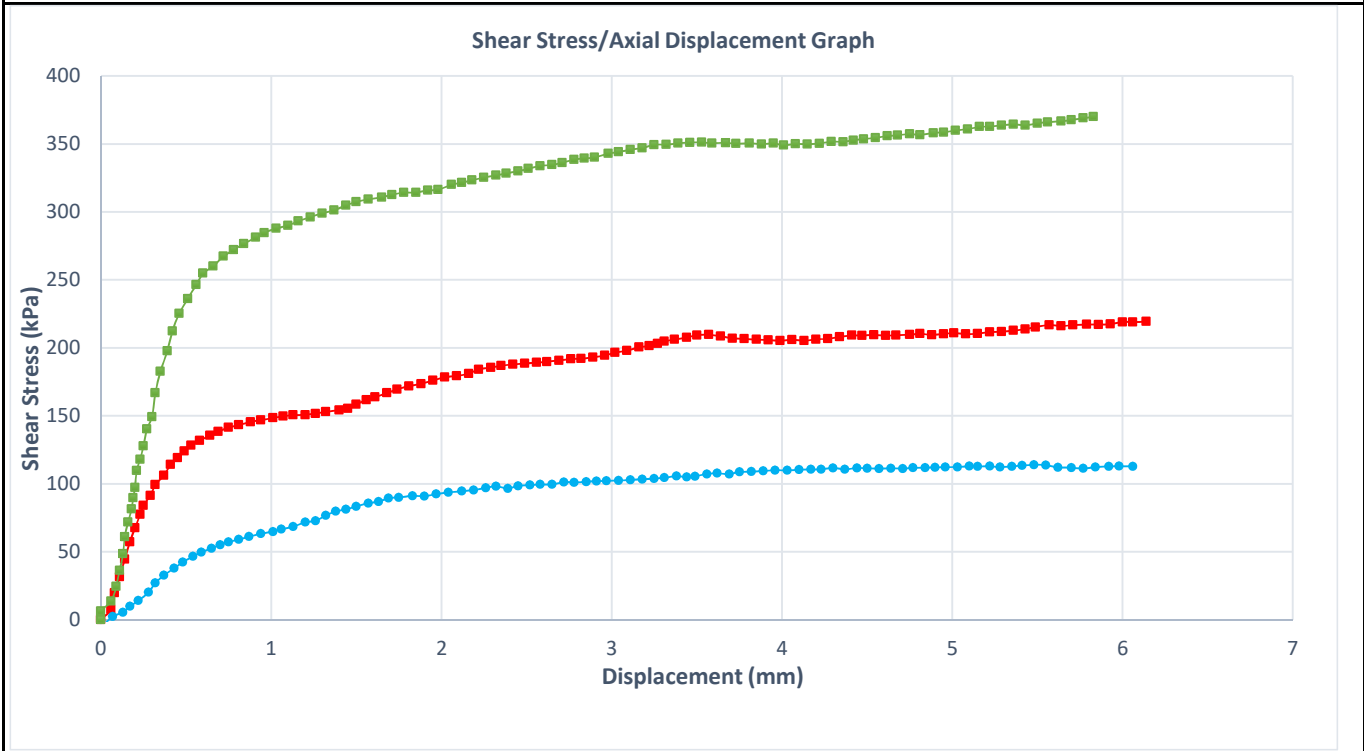
Client:	Central Queensland Coal	Report Number:	19-5353A
Address:	Level 17, 240 Queen Street, Brisbane, QLD	Report Date:	7/11/2019
Project Number:	M30863	Order Number:	-
Project Name:	CQ Coal Styx Basin Geotechnical Investigati	Test Method	AS 1289.6.2.2
Location:	STX1903G	Page 2

Failure Details				
Stage No	Normal Stress (kPa)	Peak Shear Stress (kPa)	Displacement at Failure (mm)	Test Duration (min)
1	200	114	5.48	53
2	400	220	6.35	58
3	800	373	6.33	60

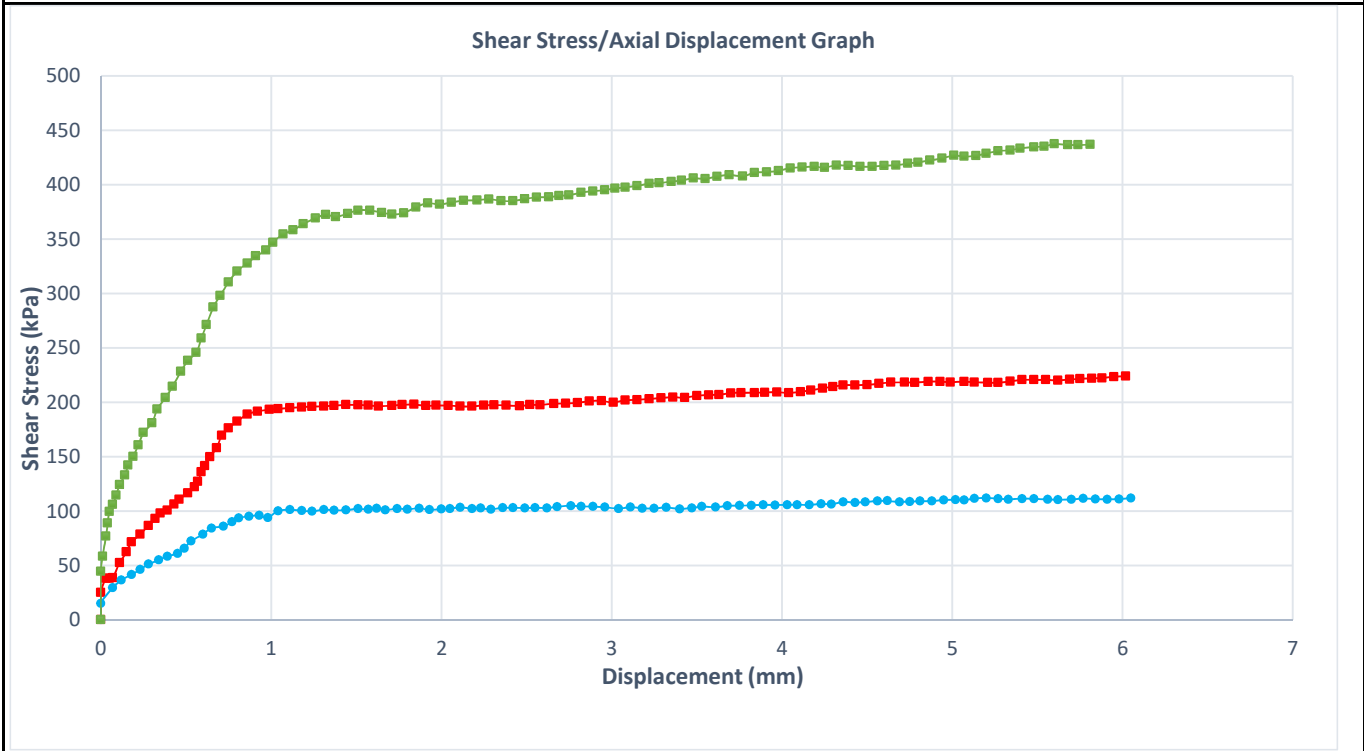
Client:	Central Queensland Coal	Report Number:	19-5367A
Address:	Level 17, 240 Queen Street, Brisbane, QLD	Report Date:	8/11/2019
Project Number:	M30863	Order Number:	-
Project Name:	CQ Coal Styx Basin Geotechnical Investigati	Test Method	AS 1289.6.2.2
Location:	STX1903G	<b>Page 2</b>

Failure Details				
Stage No	Normal Stress (kPa)	Peak Shear Stress (kPa)	Displacement at Failure (mm)	Test Duration (min)
1	200	123	7.85	65
2	400	243	7.90	64
3	800	470	7.93	66

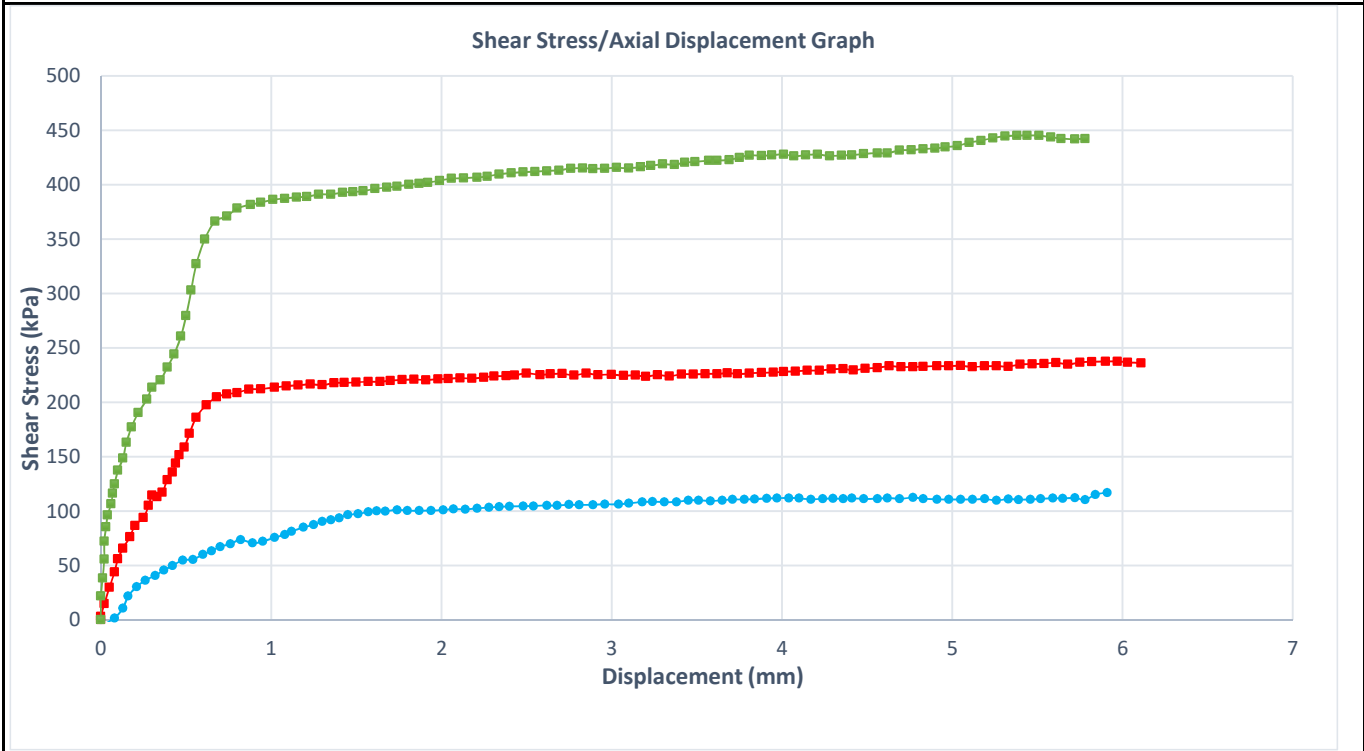
Client:	Central Queensland Coal	Report Number:	19-5387A
Address:	Level 17, 240 Queen Street, Brisbane, QLD	Report Date:	9/11/2019
Project Number:	M30863	Order Number:	-
Project Name:	CQ Coal Styx Basin Geotechnical Investigati	Test Method	AS 1289.6.2.2
Location:	STX1903G	<b>Page 2</b>

Failure Details				
Stage No	Normal Stress (kPa)	Peak Shear Stress (kPa)	Displacement at Failure (mm)	Test Duration (min)
1	200	127	7.85	62
2	400	239	6.30	54
3	800	447	6.56	57

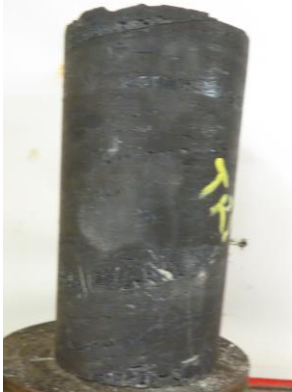
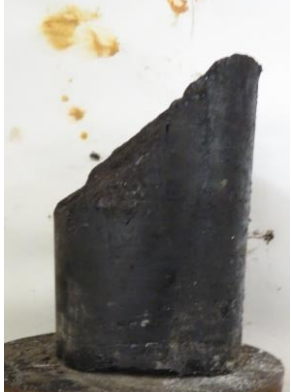
(a) Single shear plane

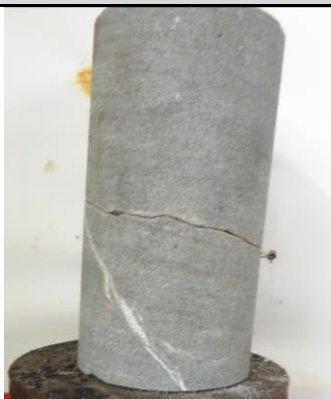
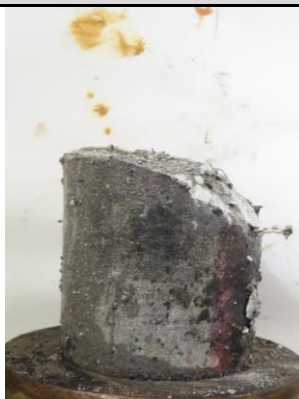
(a) Single shear plane

**Comments:** Testing was done at Room Temperature.  
Had a natural crack along a lamination that was glued prior to test.

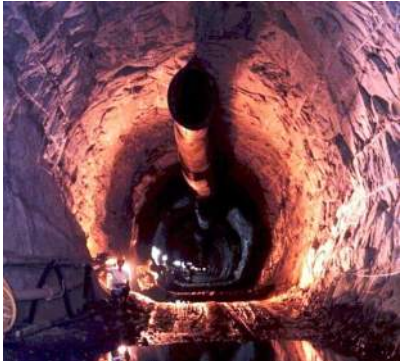
<p>Excellent quality controlled blasting or excavation by Tunnel Boring Machine results in minimal disturbance to the confined rock mass surrounding a tunnel.</p>	<p><math>D = 0</math></p>

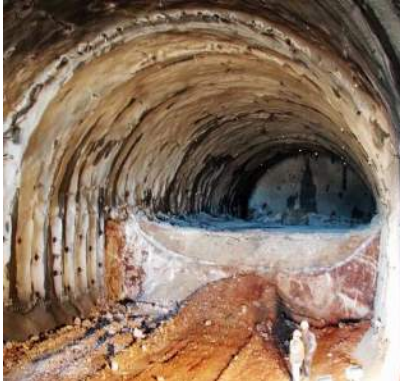
<p>Mechanical or hand excavation in poor quality rock masses (no blasting) results in minimal disturbance to the surrounding rock mass.</p> <p>Where squeezing problems result in significant floor heave, disturbance can be severe unless a temporary invert, as shown in the photograph, is placed.</p>	<p><math>D = 0</math></p> <p><math>D = 0.5</math> No invert</p>

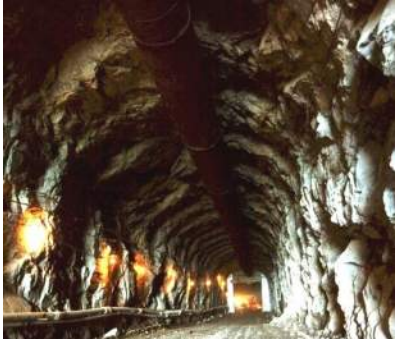
<p>Very poor quality blasting in a hard rock tunnel results in severe local damage, extending 2 or 3 m, in the surrounding rock mass.</p>	<p><math>D = 0.8</math></p>

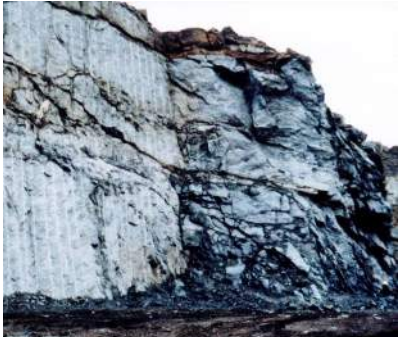
<p>Small scale blasting in civil engineering slopes results in modest rock mass damage, particularly if controlled blasting is used as shown on the left hand side of the photograph. However, stress relief results in some disturbance.</p>	<p><math>D = 0.7</math> Good blasting</p> <p><math>D = 1.0</math> Poor blasting</p>

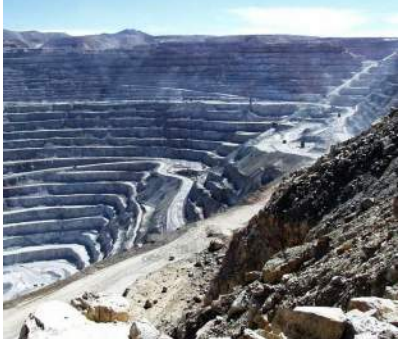
<p>Very large open pit mine slopes suffer significant disturbance due to heavy production blasting and also due to stress relief from overburden removal.</p> <p>In some softer rocks excavation can be carried out by ripping and dozing and the degree of damage to the slopes is less.</p>	<p><math>D = 1.0</math> Production blasting</p> <p><math>D = 0.7</math> Mechanical excavation</p>
