**Central Queensland Coal Project**  
**Appendix 5d – Fluvial**  
**Geomorphology Assessment**

**CQC SEIS, Version 3**

Supplementary Study Report

## Fluvial Geomorphology

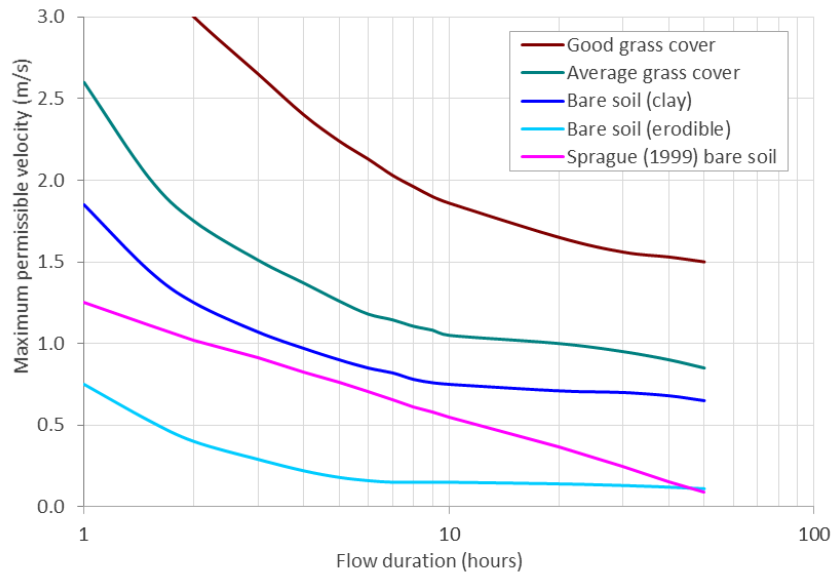
**Figure 3. Erosion limits as a function of flow duration. Based on a plots from Fischenich (2001, p. 6) and Sprague (1999).**

Tabulated values of  $U_{max}$  are for straight channels, and for sinuous channels  $U_{max}$  should be reduced. Lane (1955) recommended reductions in  $U_{max}$  of 5% for slightly sinuous channels, 13% for moderately sinuous channels, and 22% for very sinuous channels.

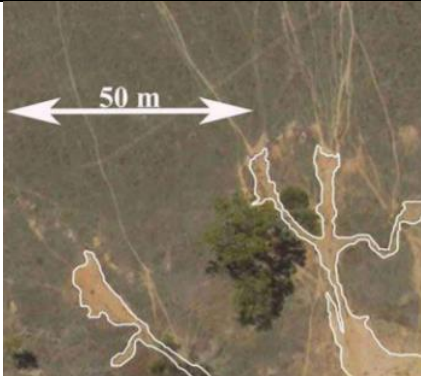
Type	Description	Example
Linear	Elongate planform morphologies without well developed secondary drainage networks. They are likely to be an incipient phase of other gully forms, which are usually preceded by rilling. They are also commonly associated with anthropogenic disturbances such as roads, stock tracks, or other linear disturbances that tend to concentrate overland flow

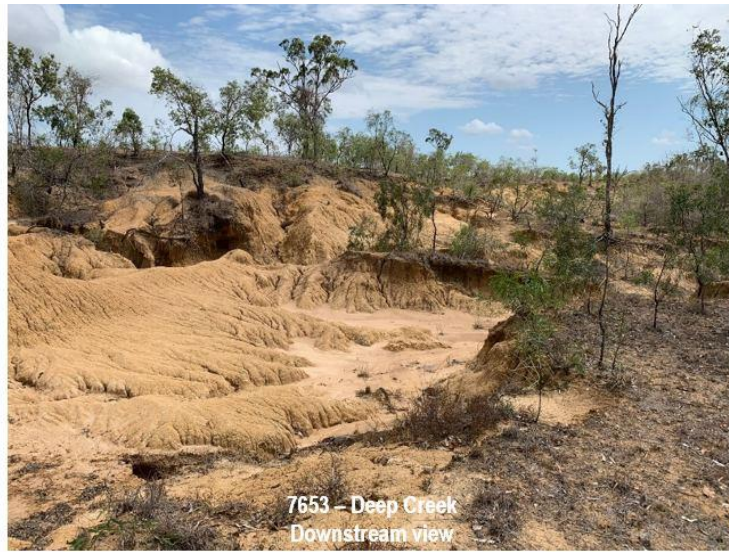
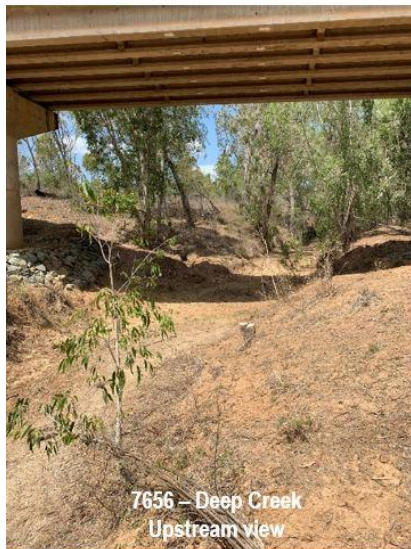
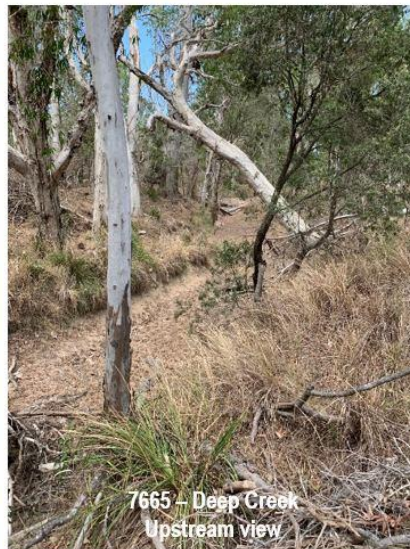
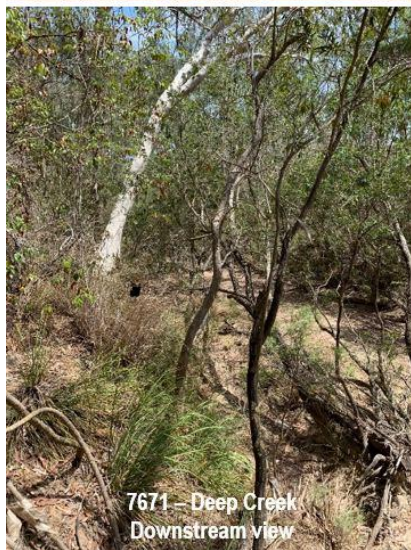
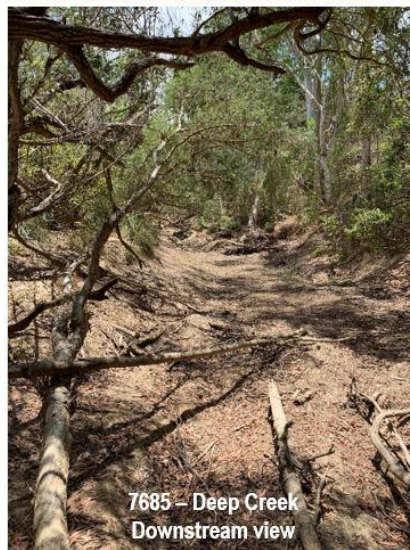
Figure 25. Deep Creek ground photographs.

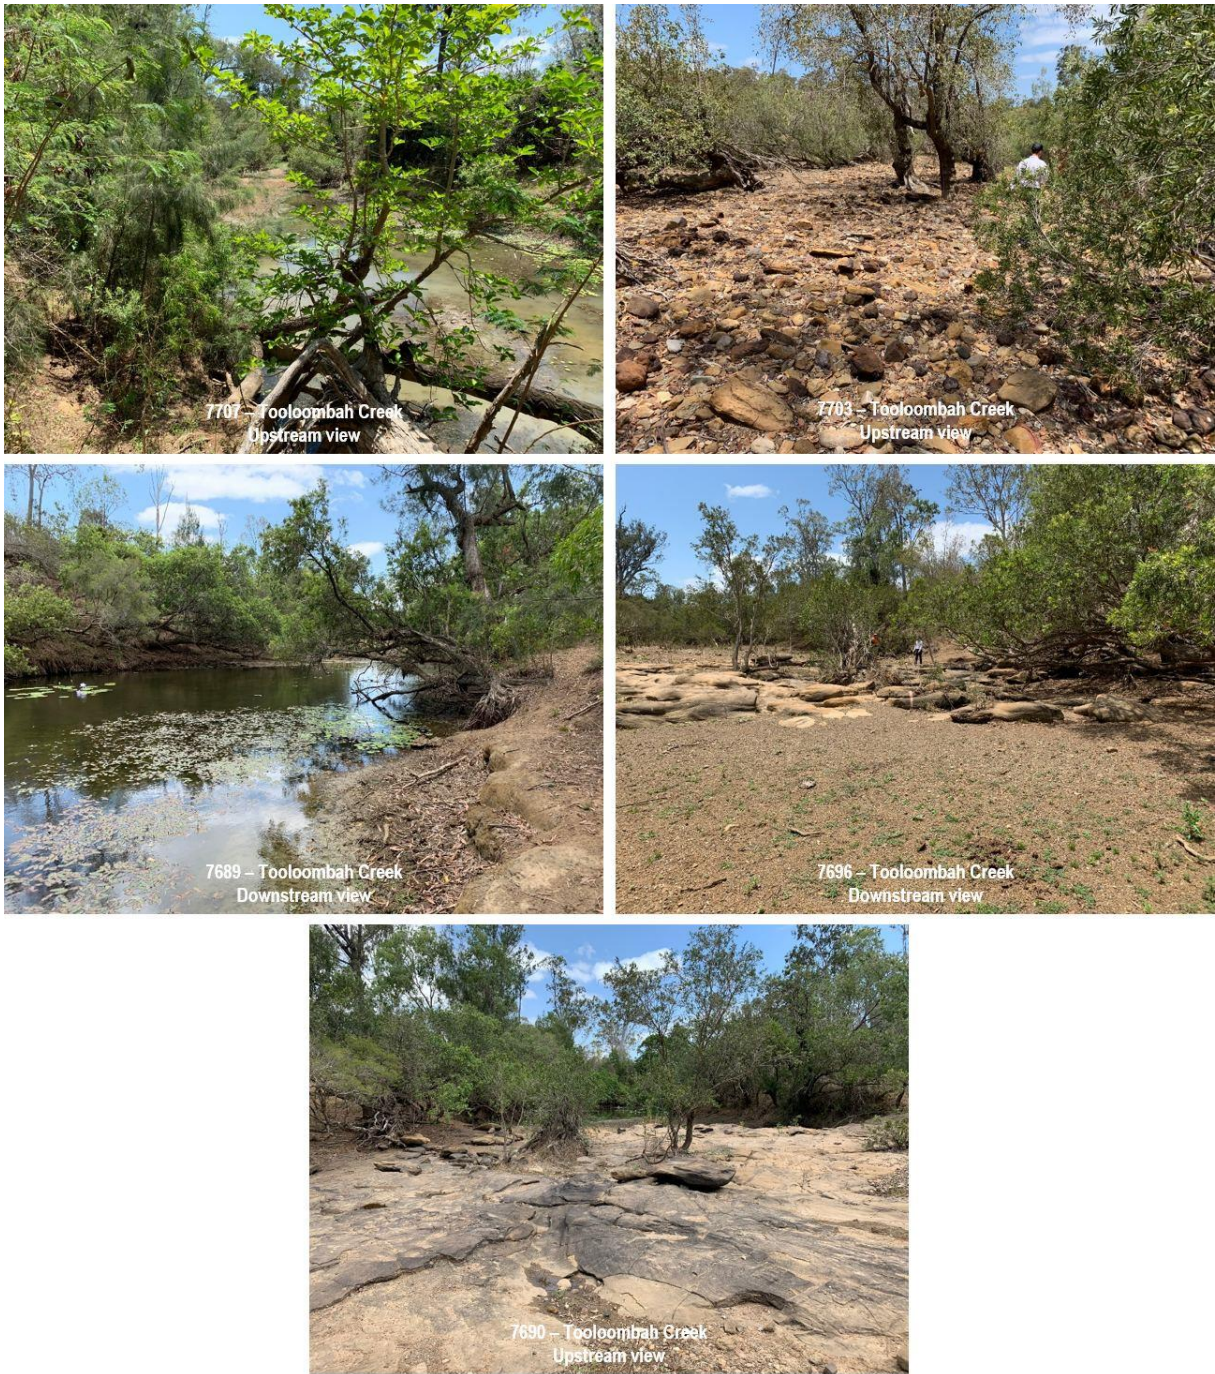
Figure 26. Tooloombah Creek ground photographs.

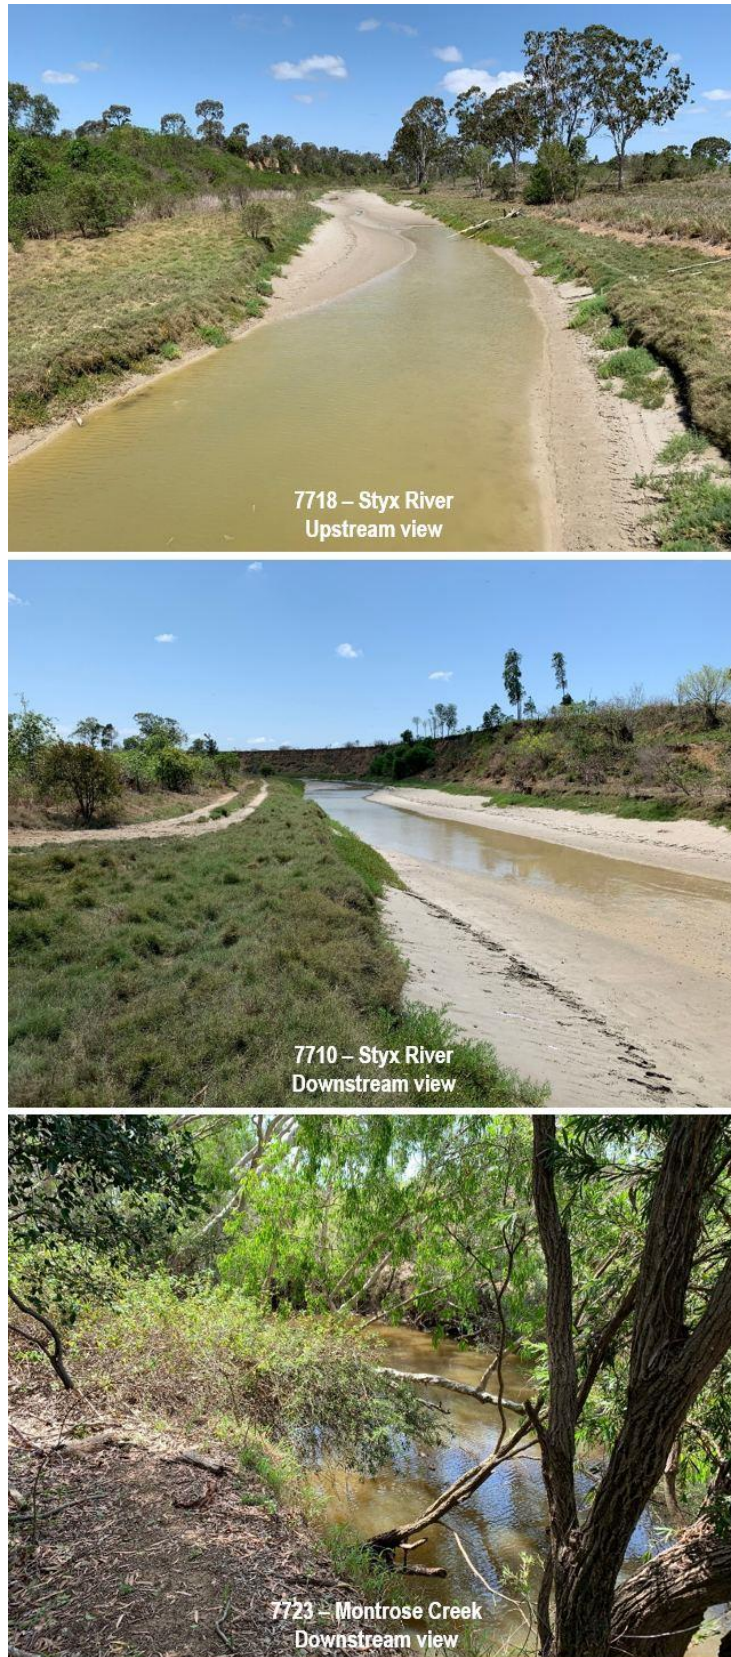
Figure 27. Styx River and Montrose Creek ground photographs.

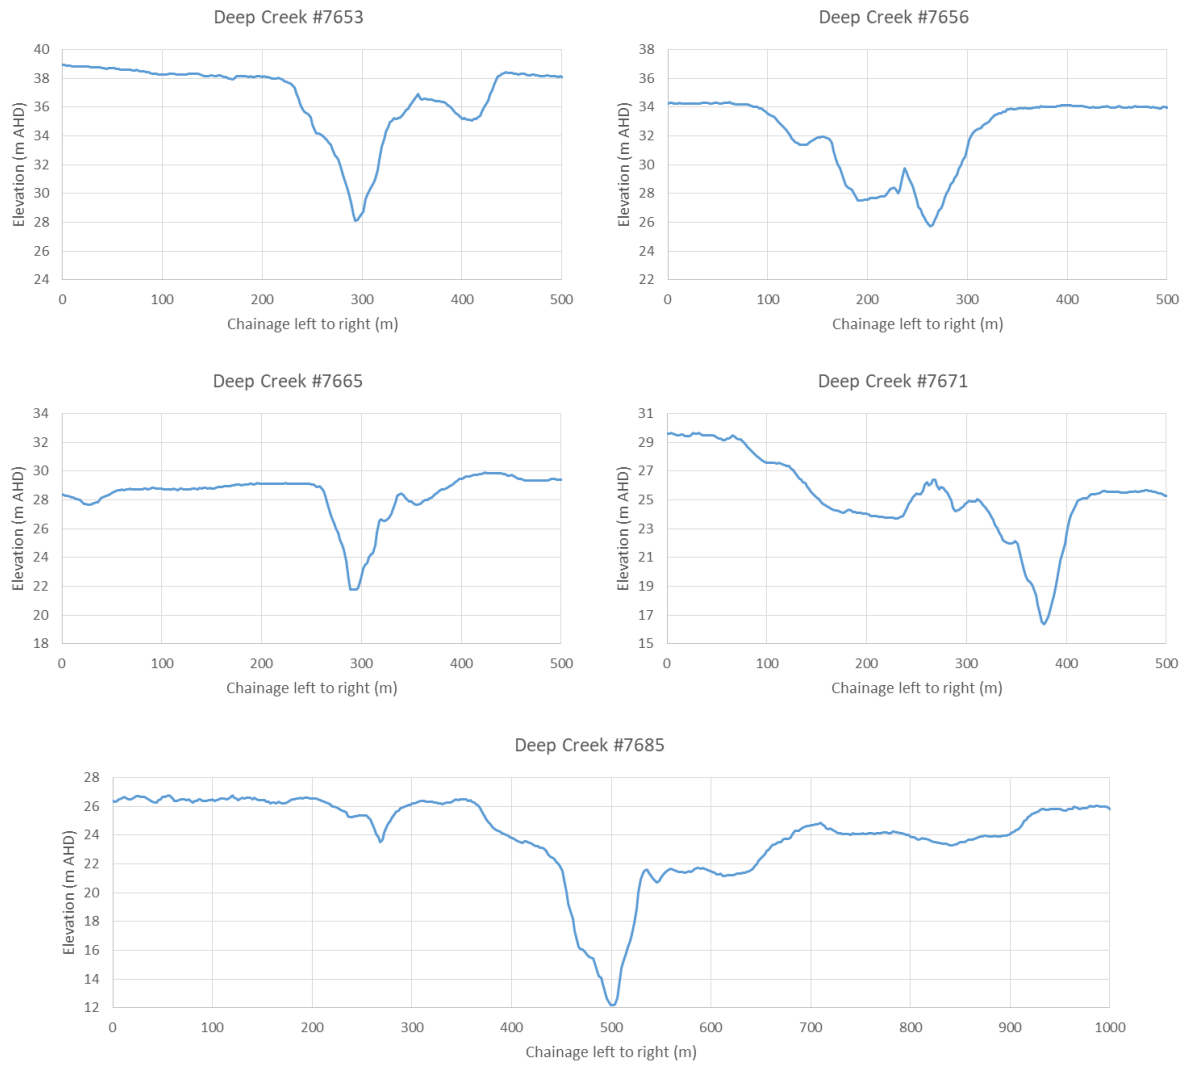
Figure 28. Deep Creek cross-sections.

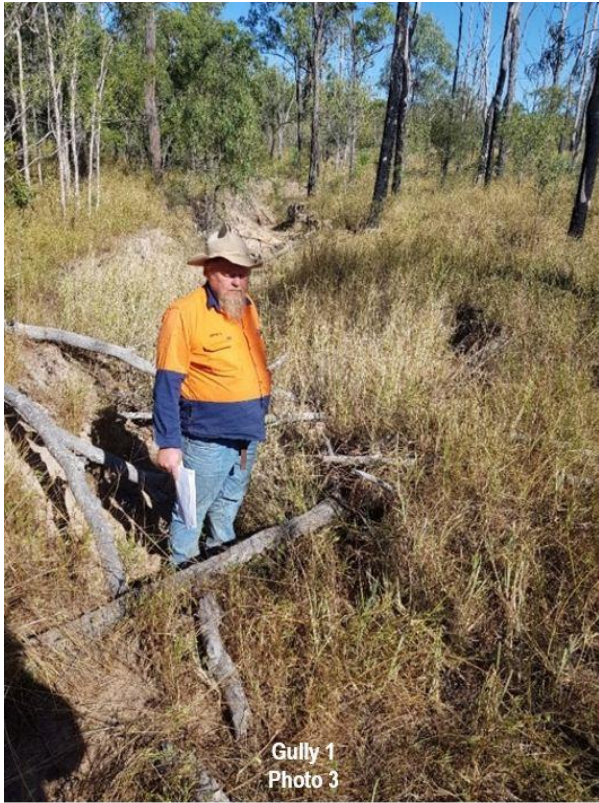
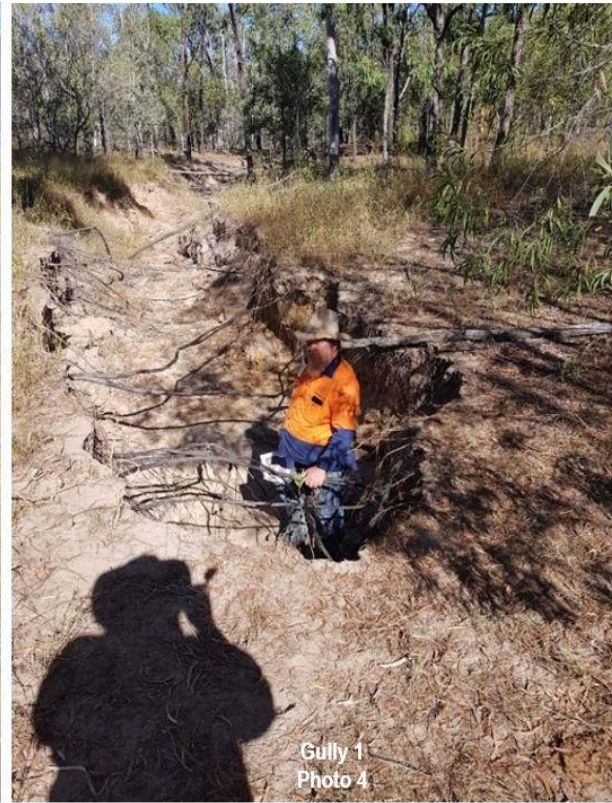
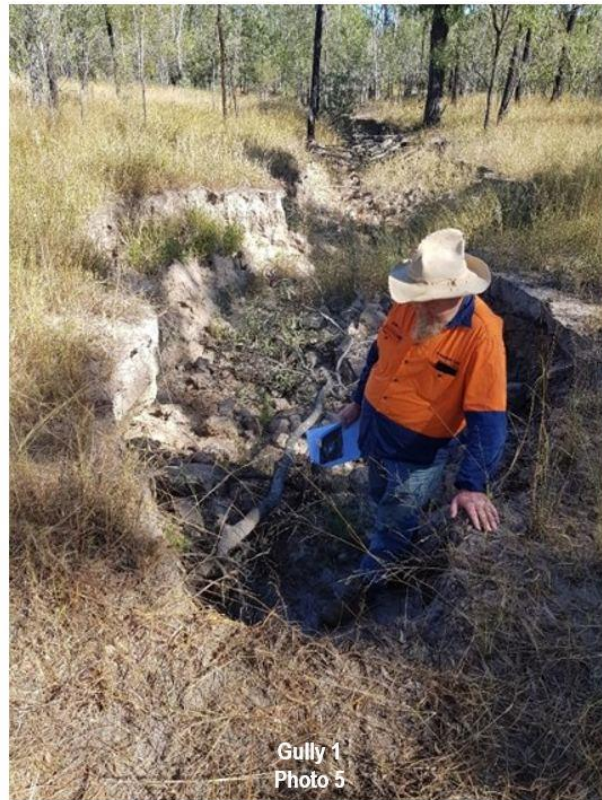
Figure 39. Gully 1 ground photographs.

photographs were available for Gullies 1 (Figure 39), 2 (Figure 40), 3 and 7 (Figure 41). One site of notable bank erosion was investigated on the Styx River (Figure 42).

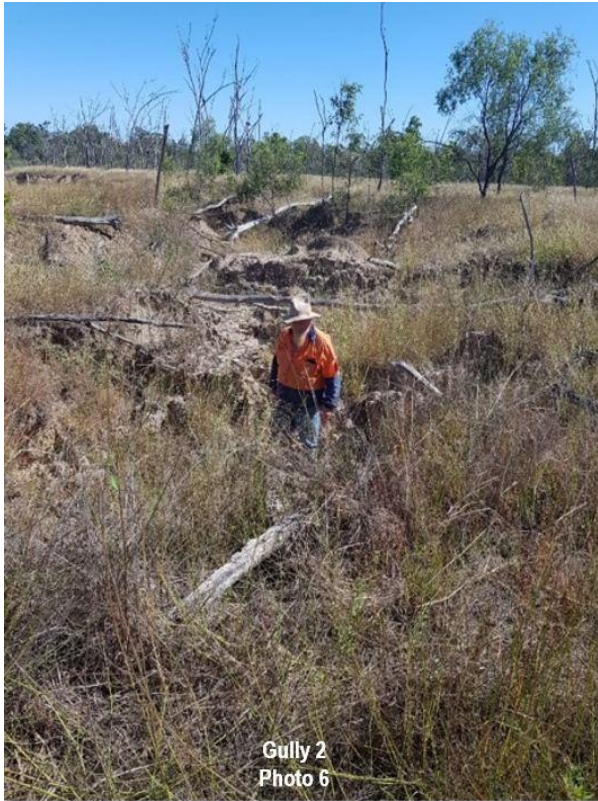
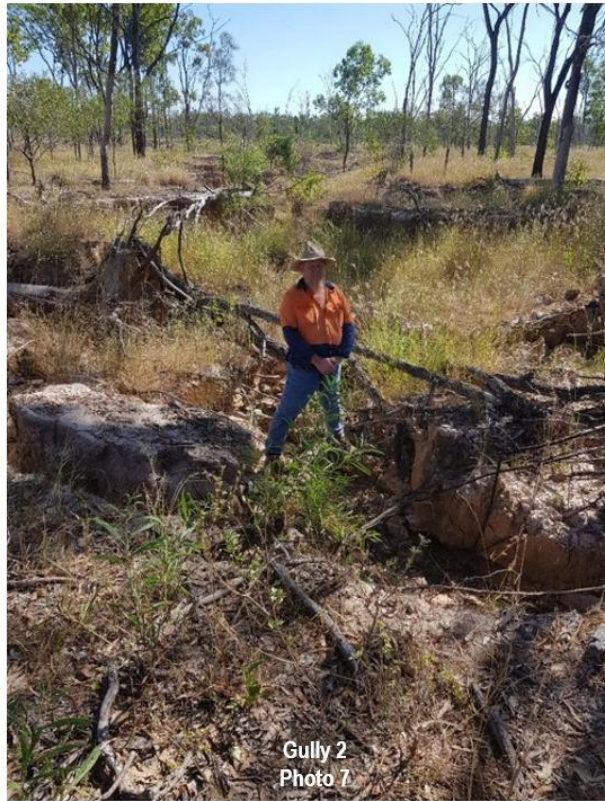
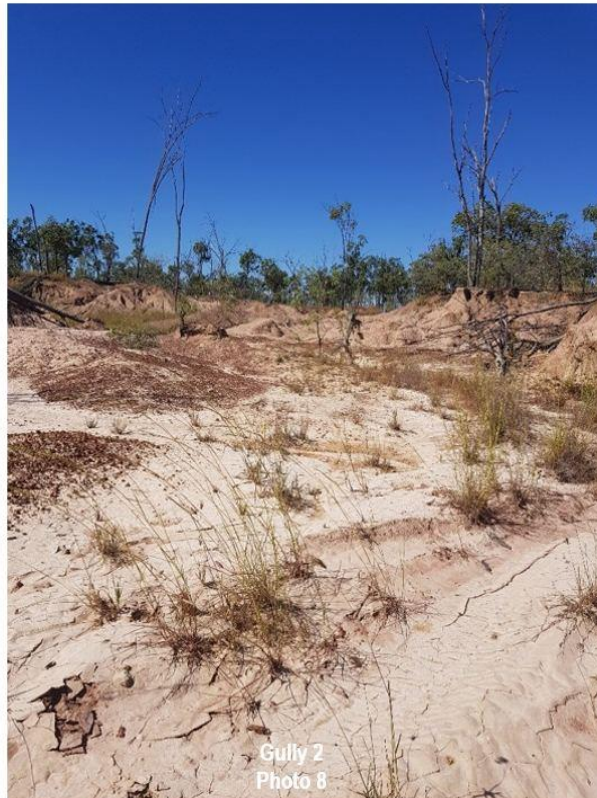
Figure 40. Gully 2 ground photographs.

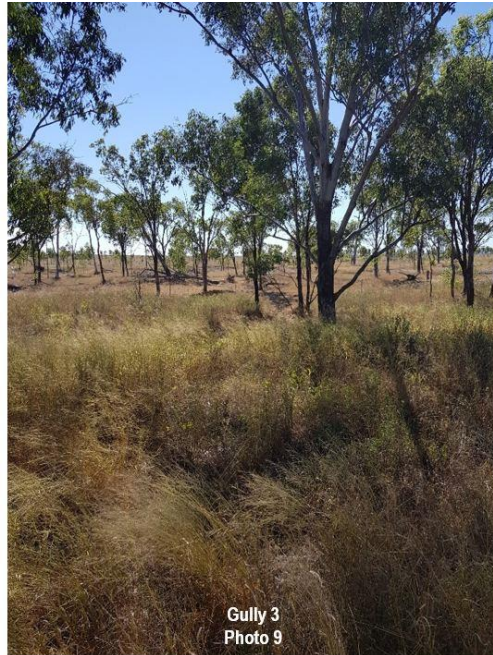
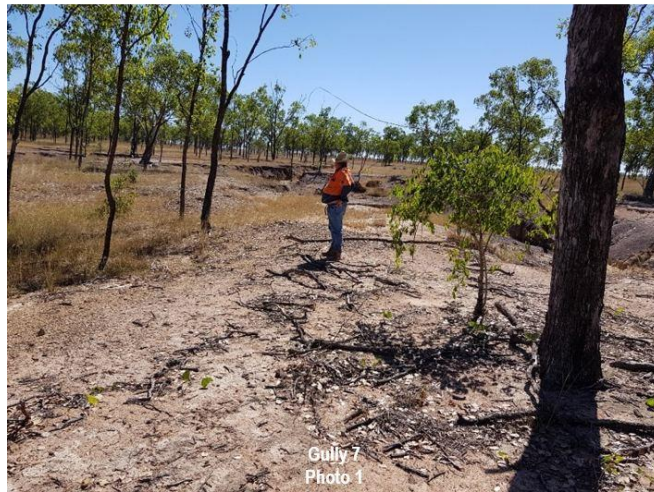
Figure 41. Gully 3 and Gully 7 ground photographs.

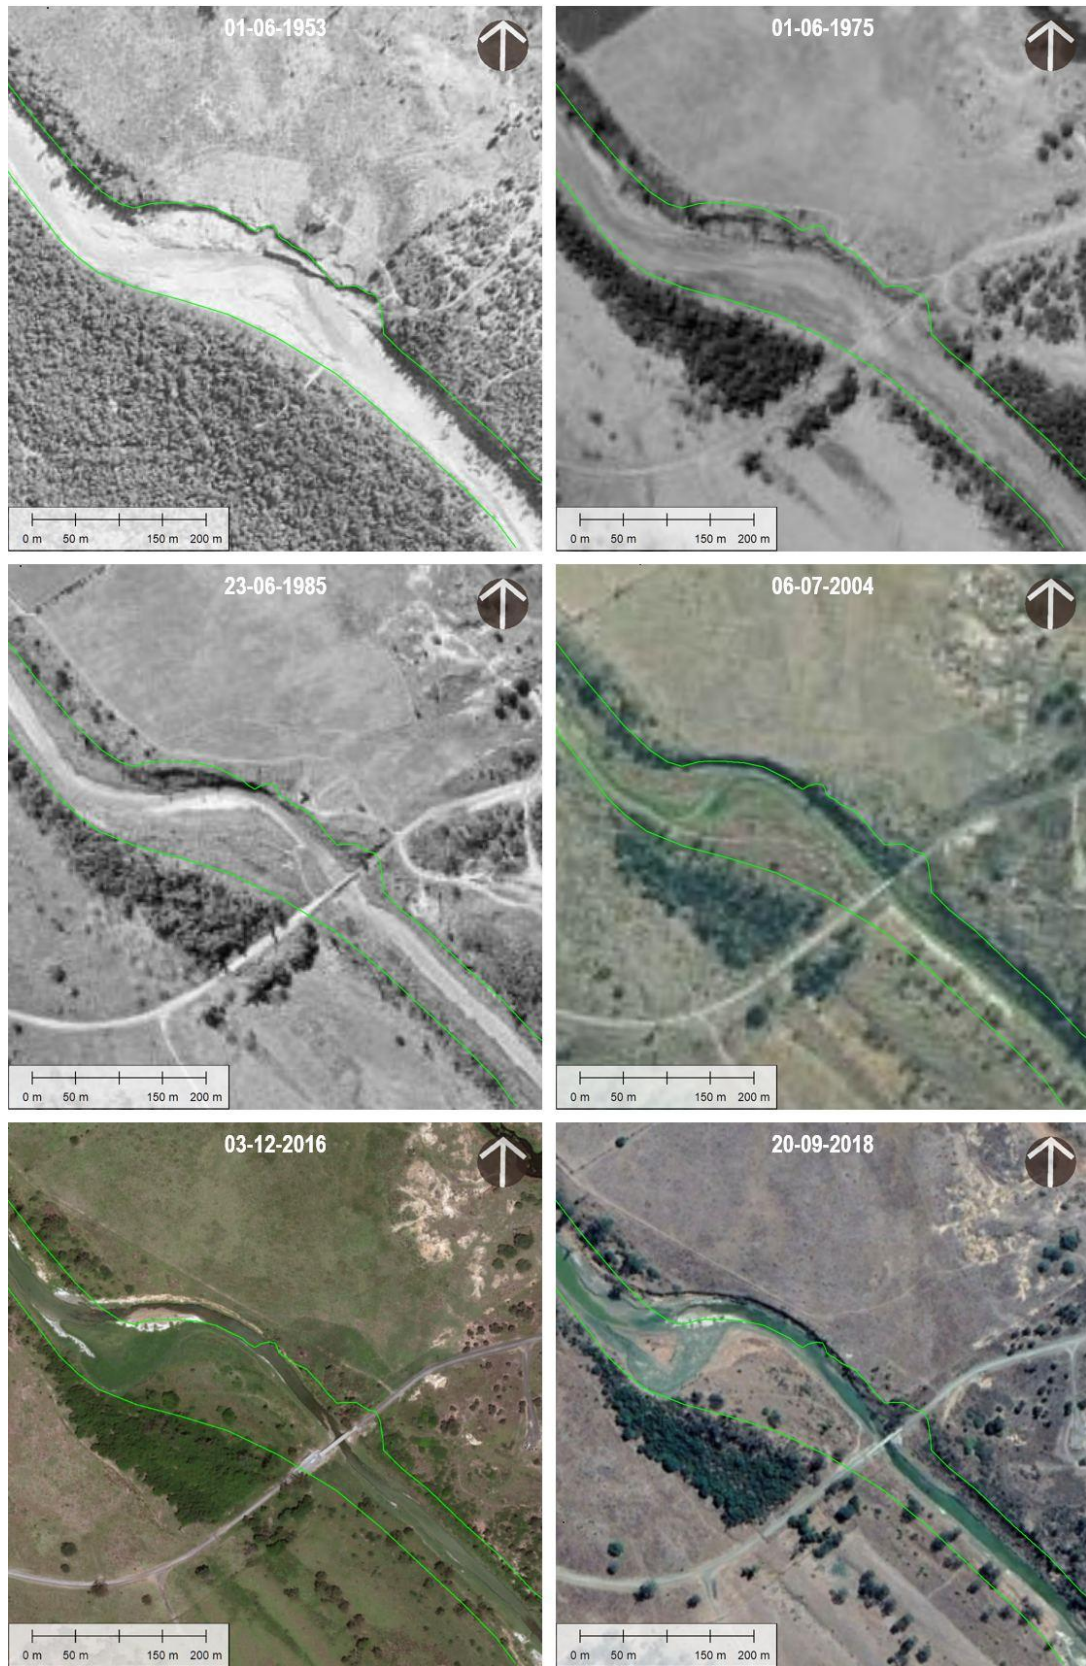
**Figure 48. Bend on the Styx River just downstream of Ogmore Road Bridge as it appears on rectified aerial photographs from 1953 to 2018.**

At the site under investigation just downstream of Ogmores Road bridge, the 1953 aerial photograph shows the left bank of the Styx River densely forested, and the right bank cleared (Figure 48). By 1975 the majority of the left bank in this area had also been cleared, but the uncleared patches of vegetation remained intact until 2018. By 1985 the toe of the right bank and the low flow channel had migrated to the right. By 2004 the top of the bank on the bend had reached the edge of the track that was formerly ~20 m from the edge. By 2016 the track had been moved inland and the top and toe of the bank had migrated a significant distance to the right. There appears to have been little to no change between 2016 and 2018 (Figure 48).
