Central Queensland Coal Project

Appendix 21 - Waterway Barrier Works Assessment

**Supplementary
Environmental Impact
Statement**

Review of waterway barrier works mapping intersecting the Central Queensland Coal Project (ML80187)

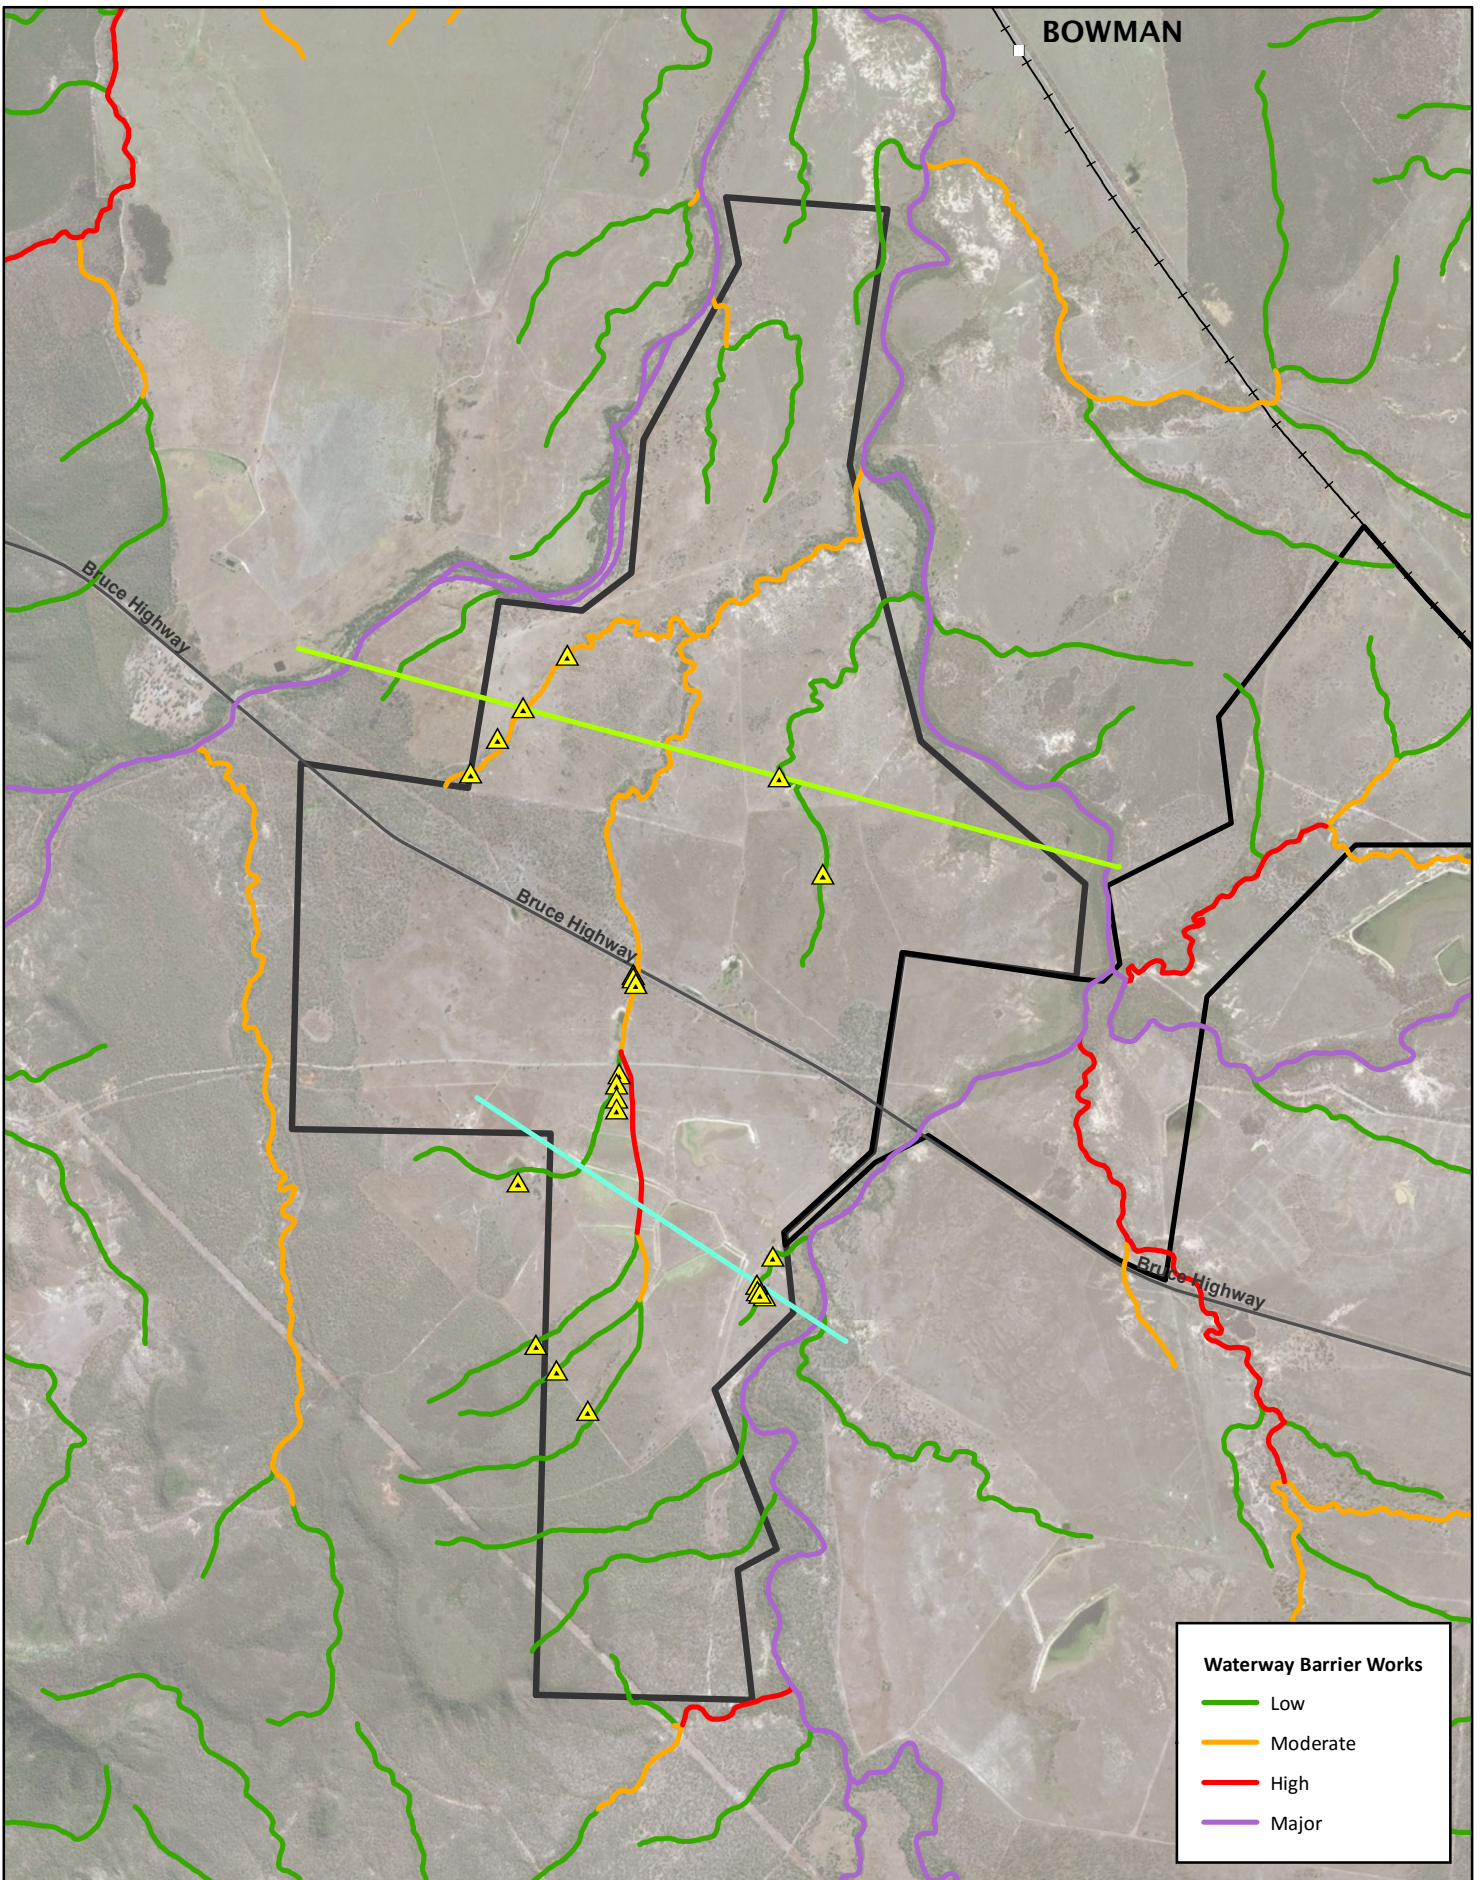
Figure 1
ML and waterway barrier mapping

The focus of this assessment is on those waterways as indicated by survey points on Figure 1. Site photograph points were established where a channel was observed in close proximity to the lines indicated by the waterways mapping layer. The text in the following (results) section refers to specific sections of creek line associated with the numbered survey points.

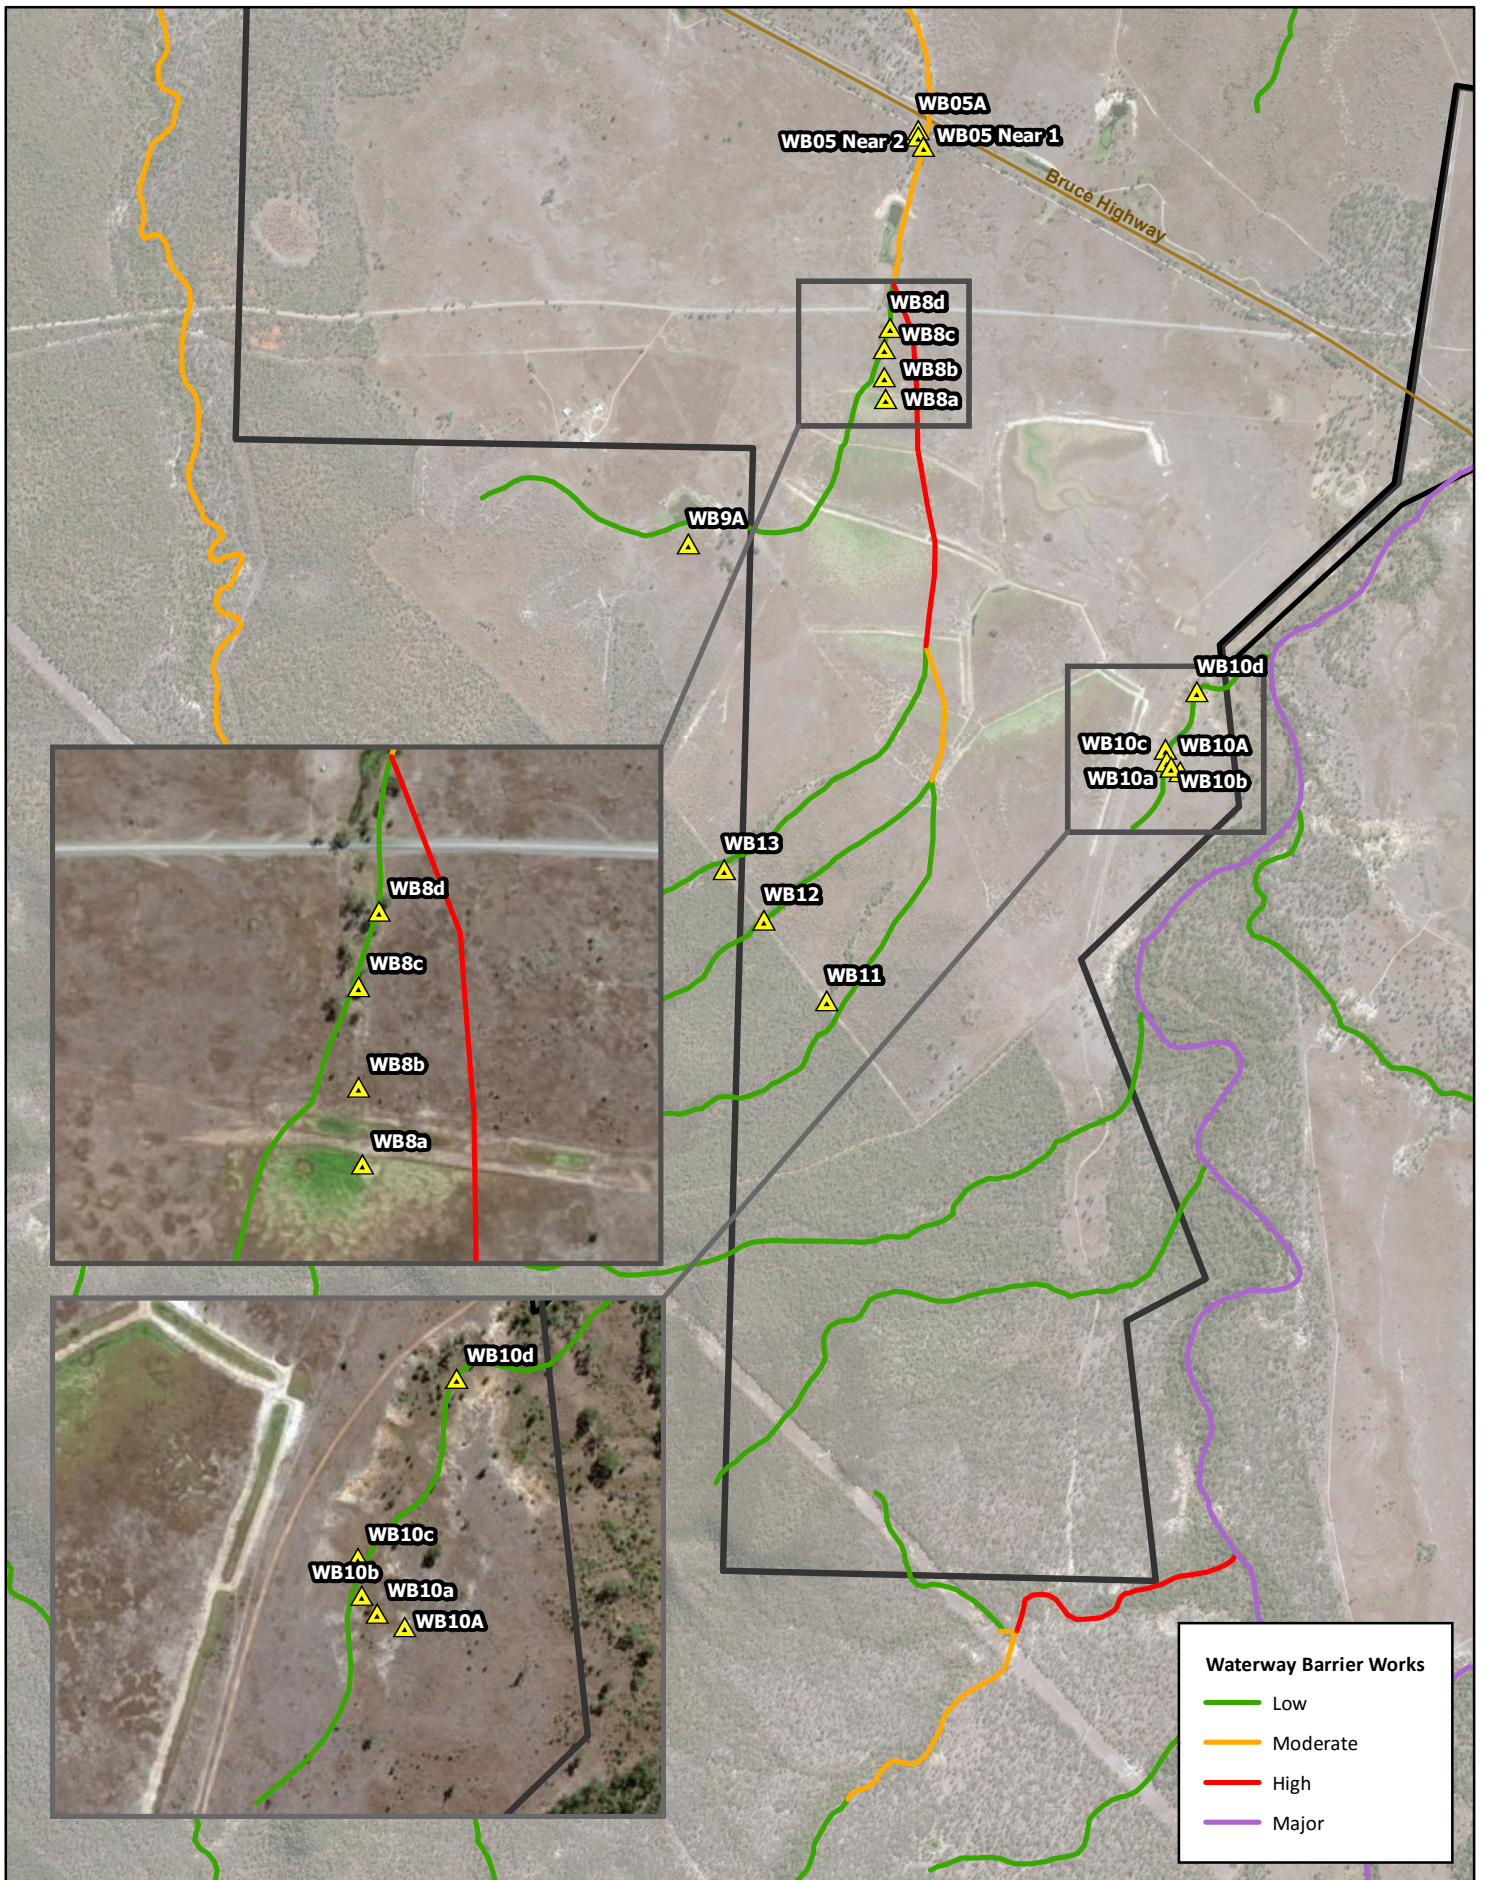
Figure A1
Waterway barrier assessment points (south of Bruce Highway) for Styx Project

1. The Project ML is bisected by the Bruce Highway (labelled in Figure 1). The waterways upstream (south) of a dammed area to the south of the highway have been heavily modified. A number of berms have been constructed across the original waterways in order to create flooded pasture areas for cattle grazing which has effectively removed the channel. When wet the bermed areas have become densely vegetated with an introduced weed – Olive Hymenachne (*Hymenachne amplexicaulis*) (listed as a category 3 weed under the State’s *Biosecurity Act 2014*). The bed and banks have been removed and are no longer continuous in this system as indicated in aerial imagery and site inspections. Refer Attachment 1 for site photos associated with several survey points associated with this system – WB8, WB9, WB11, WB12 and WB13.

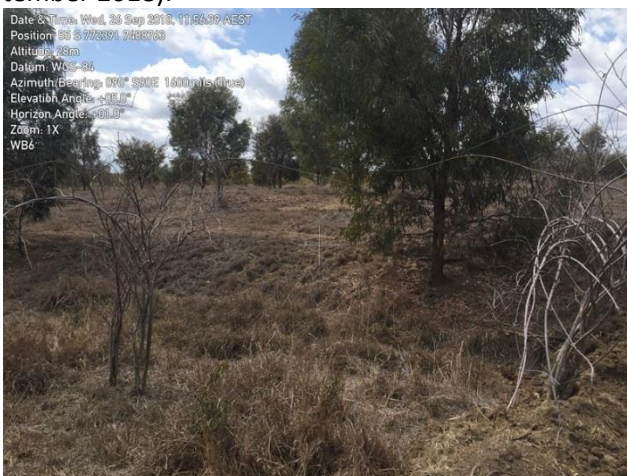
Photo looking east from WB6 from channel
