**Central Queensland Coal Project
Appendix 10g – 2018 Waterway
Barrier Works Map Amendment
Request**

Review of waterway barrier works mapping intersecting the Central Queensland Coal Project (ML80187)

Attachment A – Styx Coal Project waterways on south side of Bruce Highway

Attachment B – Styx Coal Project waterways on north side of Bruce Highway

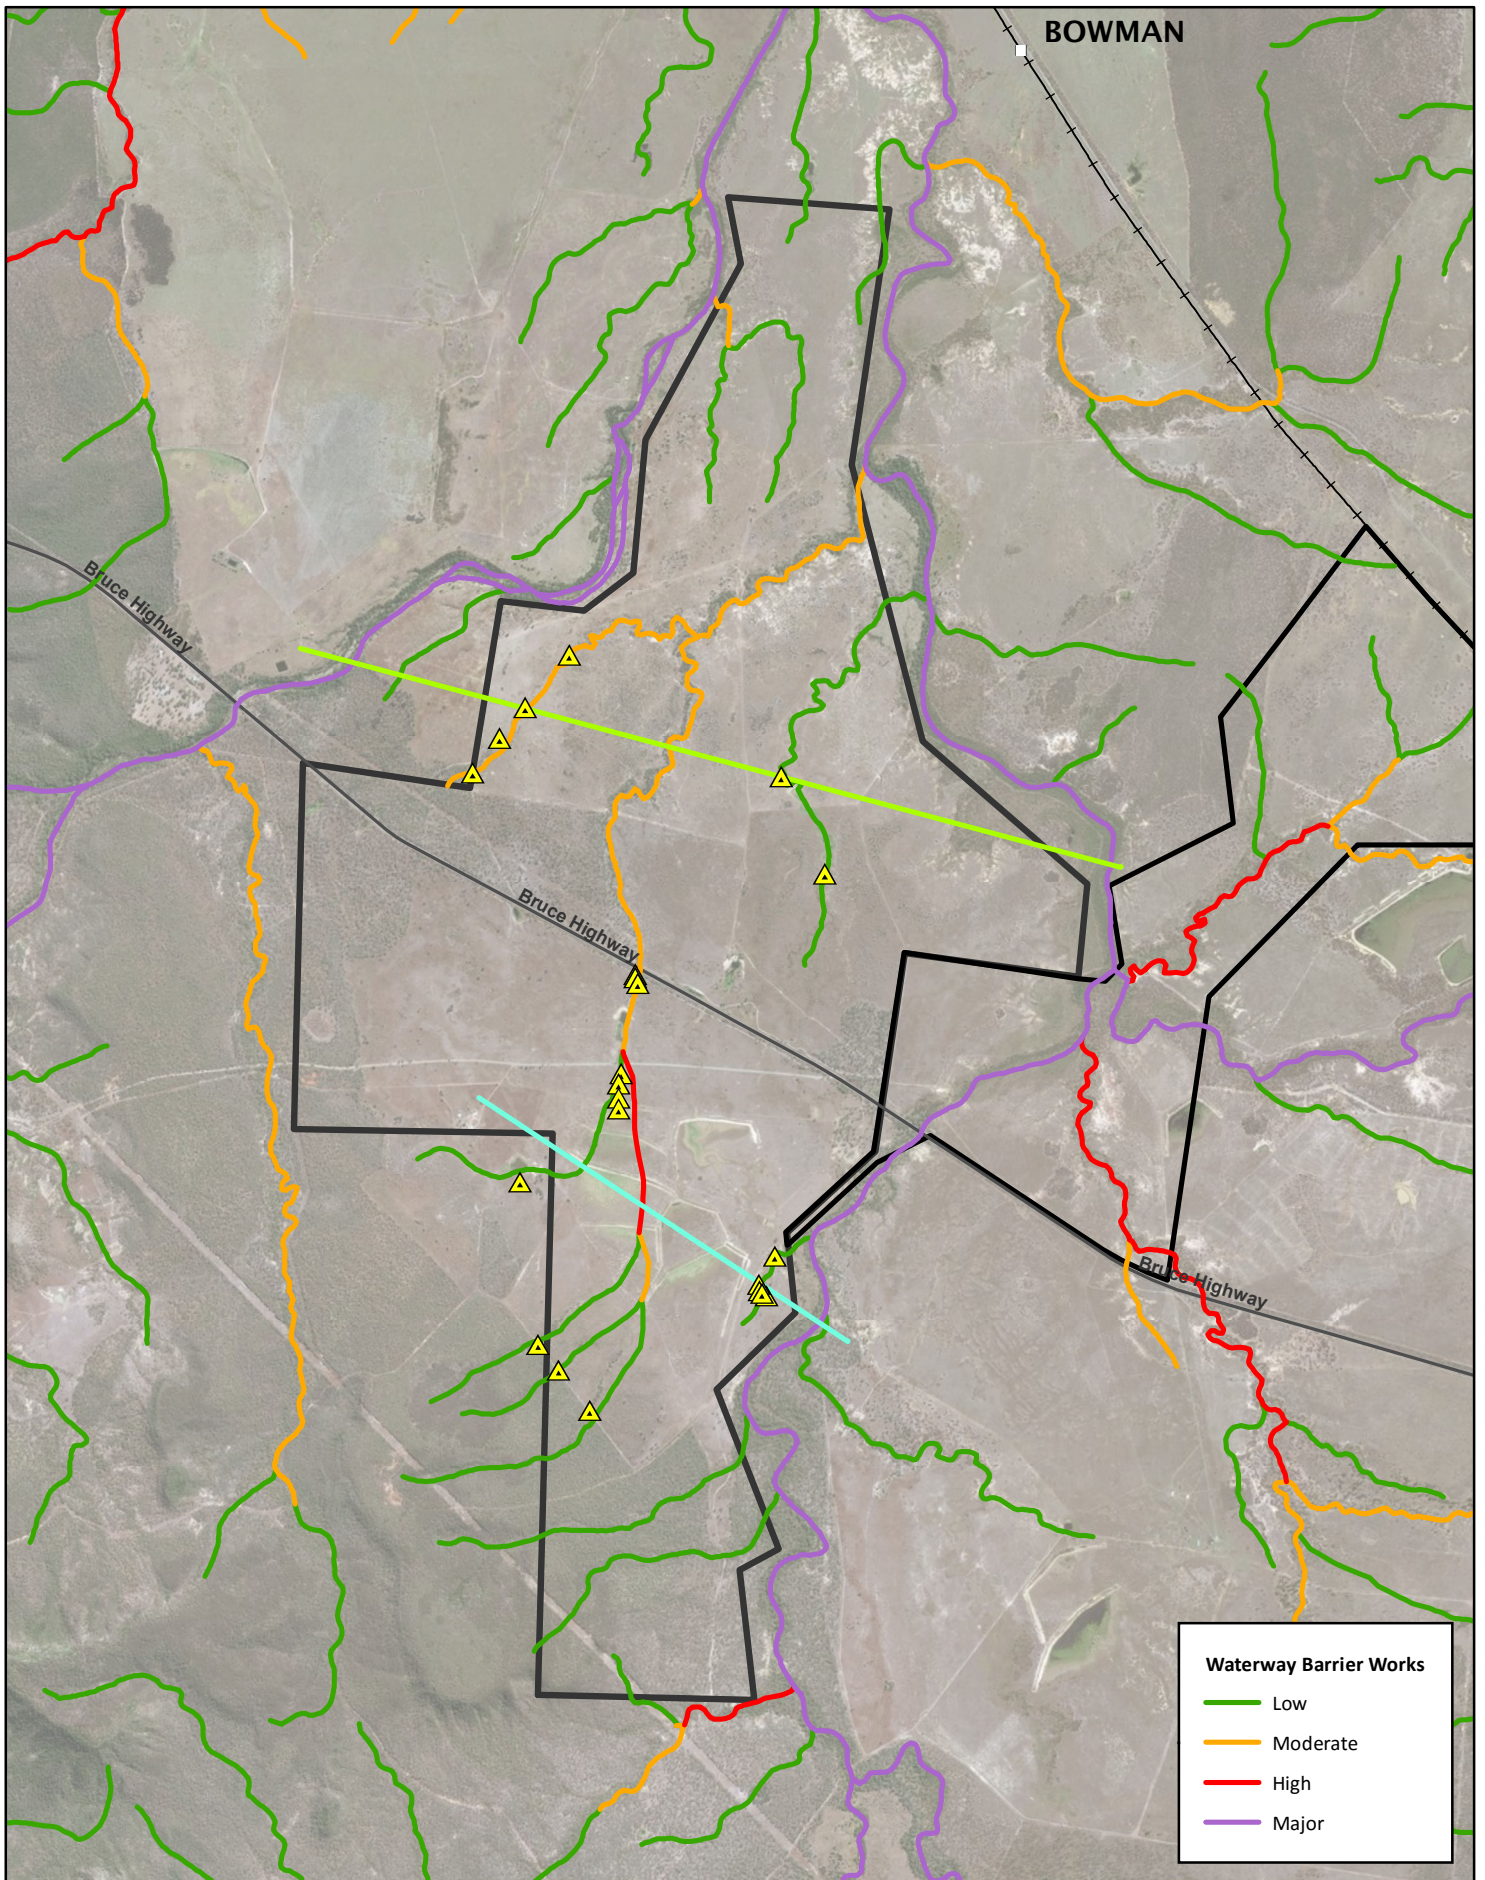
Figure 1
ML and waterway barrier mapping

The focus of this assessment is on those waterways as indicated by survey points on Figure 1. Site photograph points were established where a channel was observed in close proximity to the lines indicated by the waterways mapping layer. The text in the following (results) section refers to specific sections of creek line associated with the numbered survey points.
